Bat Survey Report

Ringers Road, Bromley

5th August 2021

TG Report No. 13577_R02_ZD_CW

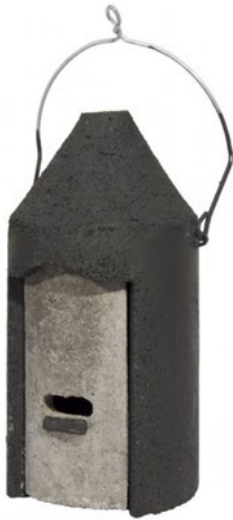
Figure A4.1. Schwegler 2F bat box⁴

- A4.1. External bat boxes (such as the Schwegler 2F bat box; **Figure A4.1**) could be installed onto the building walls of the site post-development or on suitably big enough trees or internal bat boxes (such as the Ibstock Enclosed bat box "C"; **Figure A4.2**) could be integrated into the scheme design. These boxes offer suitable roosting conditions for crevice dwelling species such as common or soprano pipistrelle.

- A4.2. The bat boxes should be installed at least 4m off the ground and positioned with an unobstructed approach. If possible, they should be placed where there will be no lighting directed towards them.
- A4.3. As temperature is known to be an important factor influencing the success of artificial roost boxes⁶ the boxes are to be sited on the south, west and east aspects of trees or buildings to receive maximum amounts of sunlight and warmth.

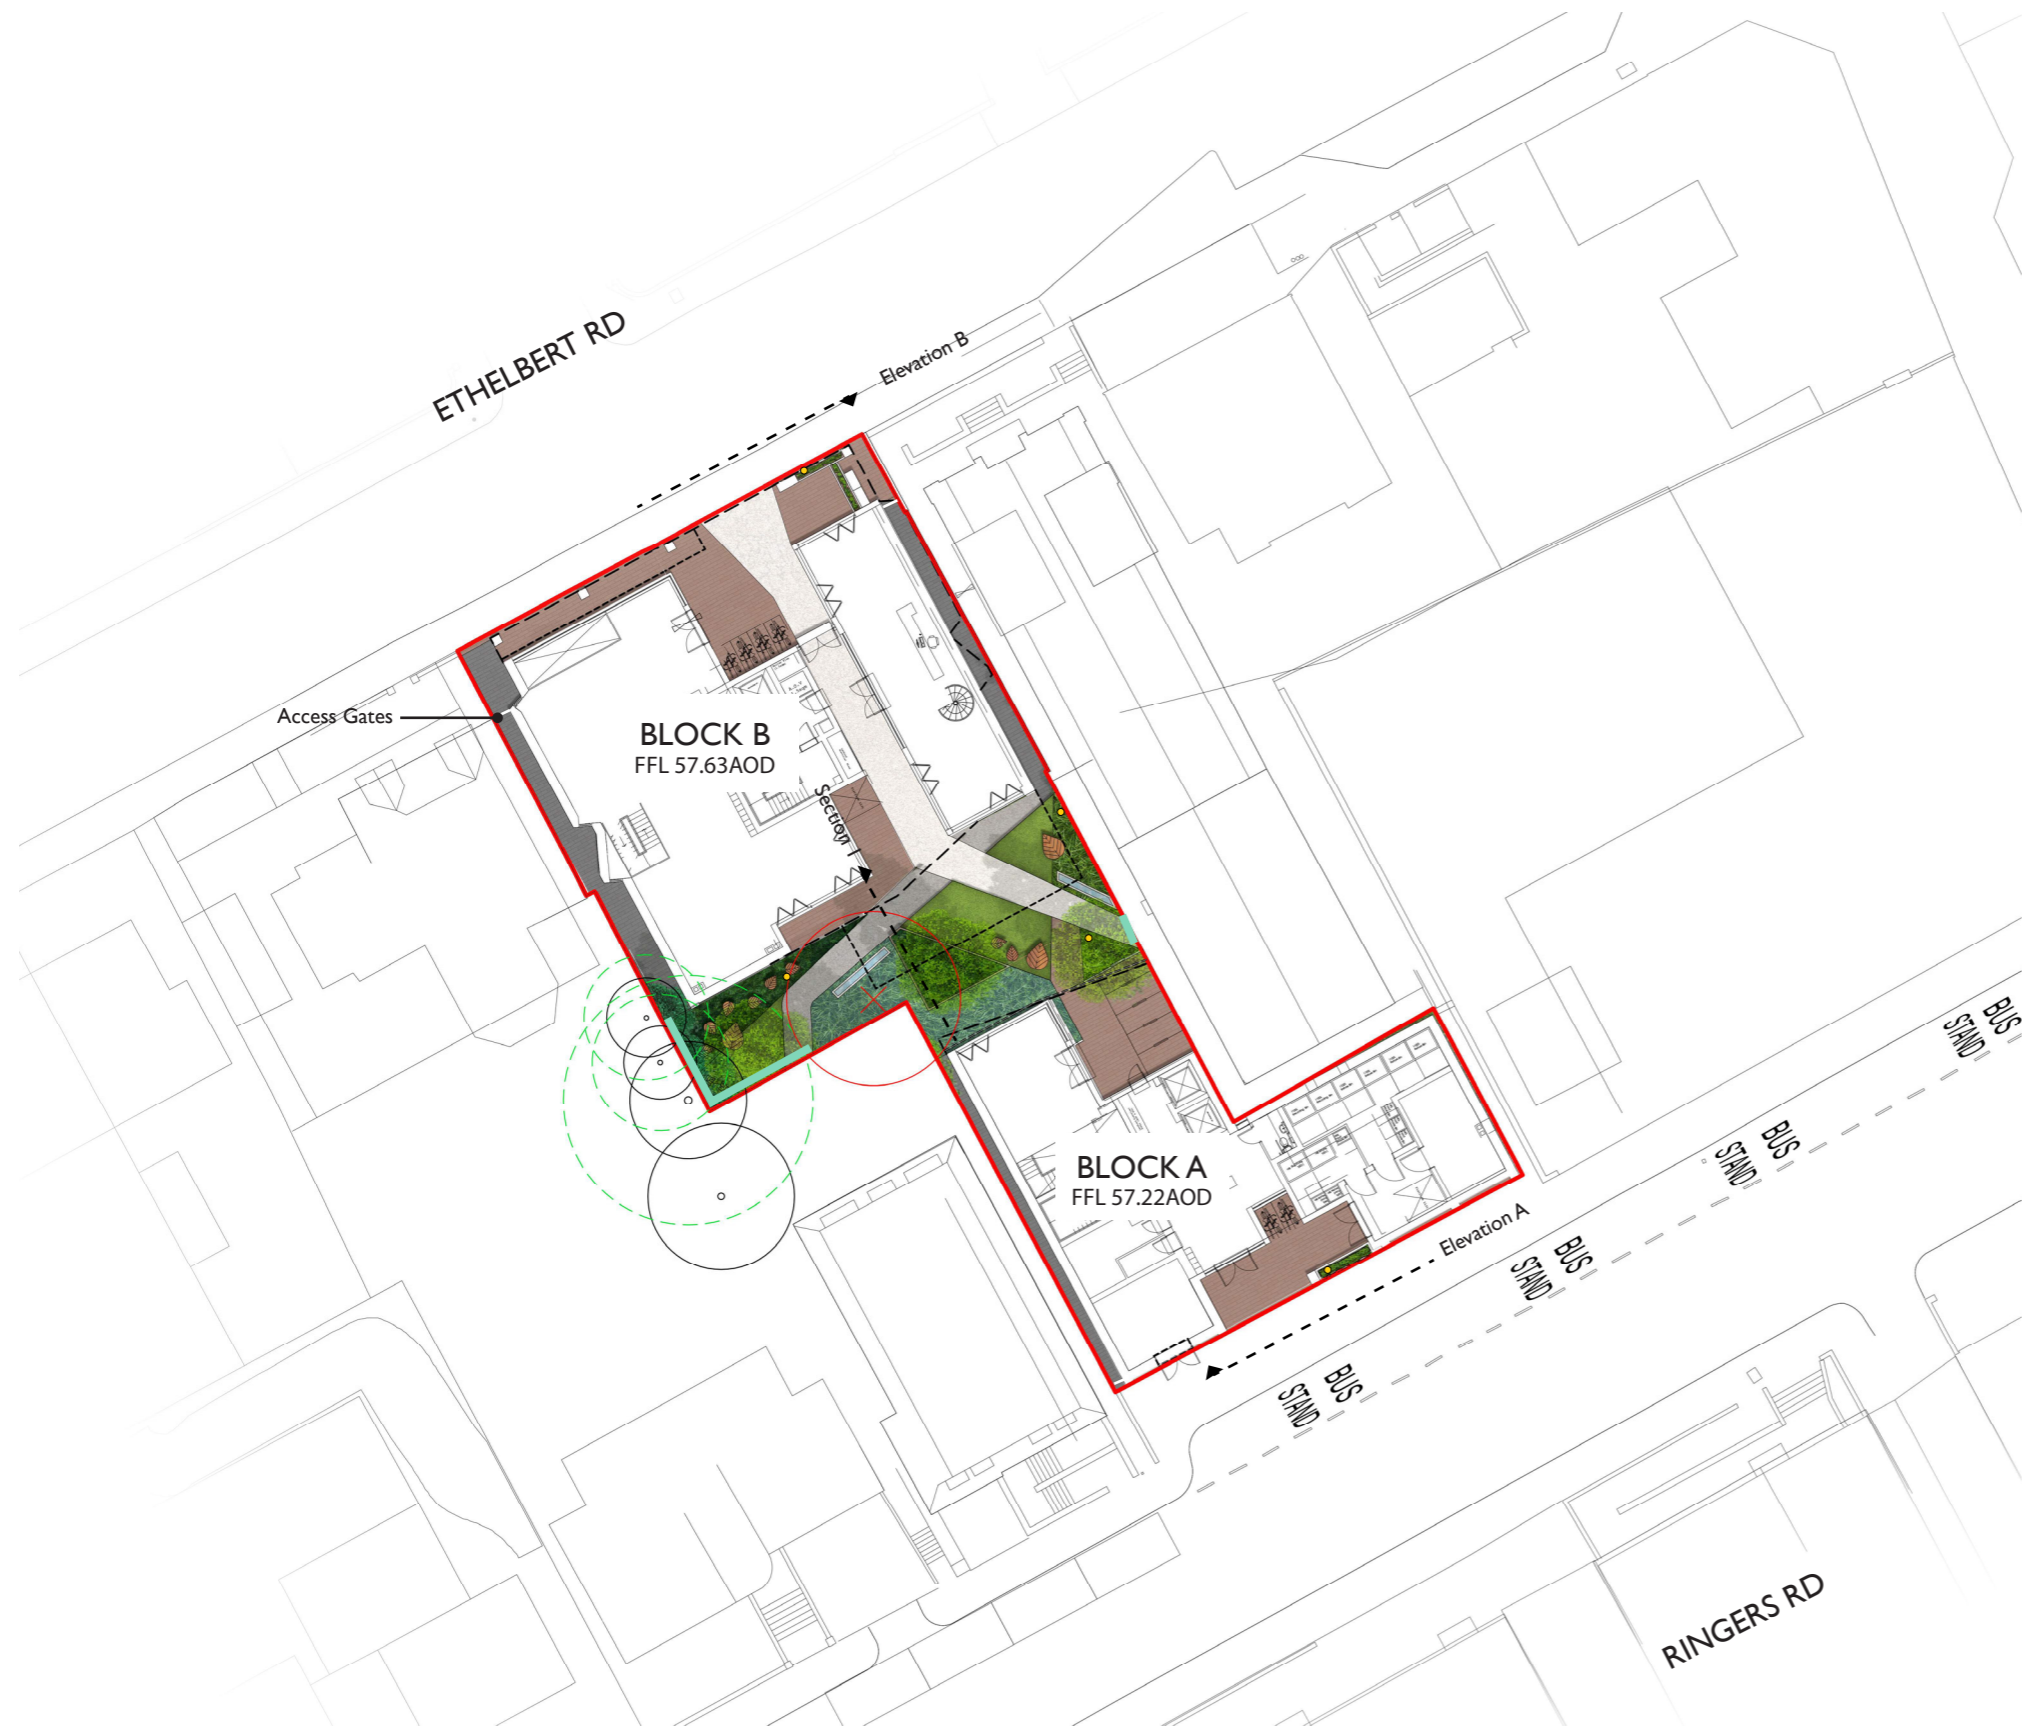
Landscape Plan RRB-ETL-XX-00-DR-L-0100

As per the Tyler Grange preliminary 'Ecological Appraisal and Preliminary Bat Roost Assessment' (dated 19th of November 2020), as the Site is predominantly existing buildings, hard standing and amenity grass, most of the habitats to be lost are of negligible ecological importance, and no specific mitigation is required.

Through consultation with Consultant Ecologists, several items have been suggested to encourage Ecology within the proposed development.

Bird boxes, Swift boxes and Bat boxes have all been recommended with suggested locations marked on the plan. Some plant species also have been selected through recommendations by the Ecologist, please see the planting page for details.

- 3.8. To mitigate for the loss of potential roosting sites, bat boxes should be incorporated into the scheme design. These can either take the form of free hanging bat boxes which can be hung on suitably sized trees or onto the walls of the residential building, or internal bat boxes that can be integrated into the building. See **Appendix 4** for bat box specifications and appended **Ecology page from Design and Access Statement RRB-ETL-XX-00-RP-L-0702-DAS-14** for locations).

- 3.13. Roosting opportunities could be provided at the site through installing either exterior bat boxes at the site post-development, such as the Schwegler 2F bat box, or by incorporating integrated internal bat boxes within the scheme design, such as the Ibstock Enclosed bat box "C". Any bat boxes integrated into the site design should be installed in suitable locations on proposed buildings (See **Appendix 4** for more details on bat box specification and appended **Ecology page from Design and Access Statement RRB-ETL-XX-00-RP-L-0702-DAS-14** for locations).

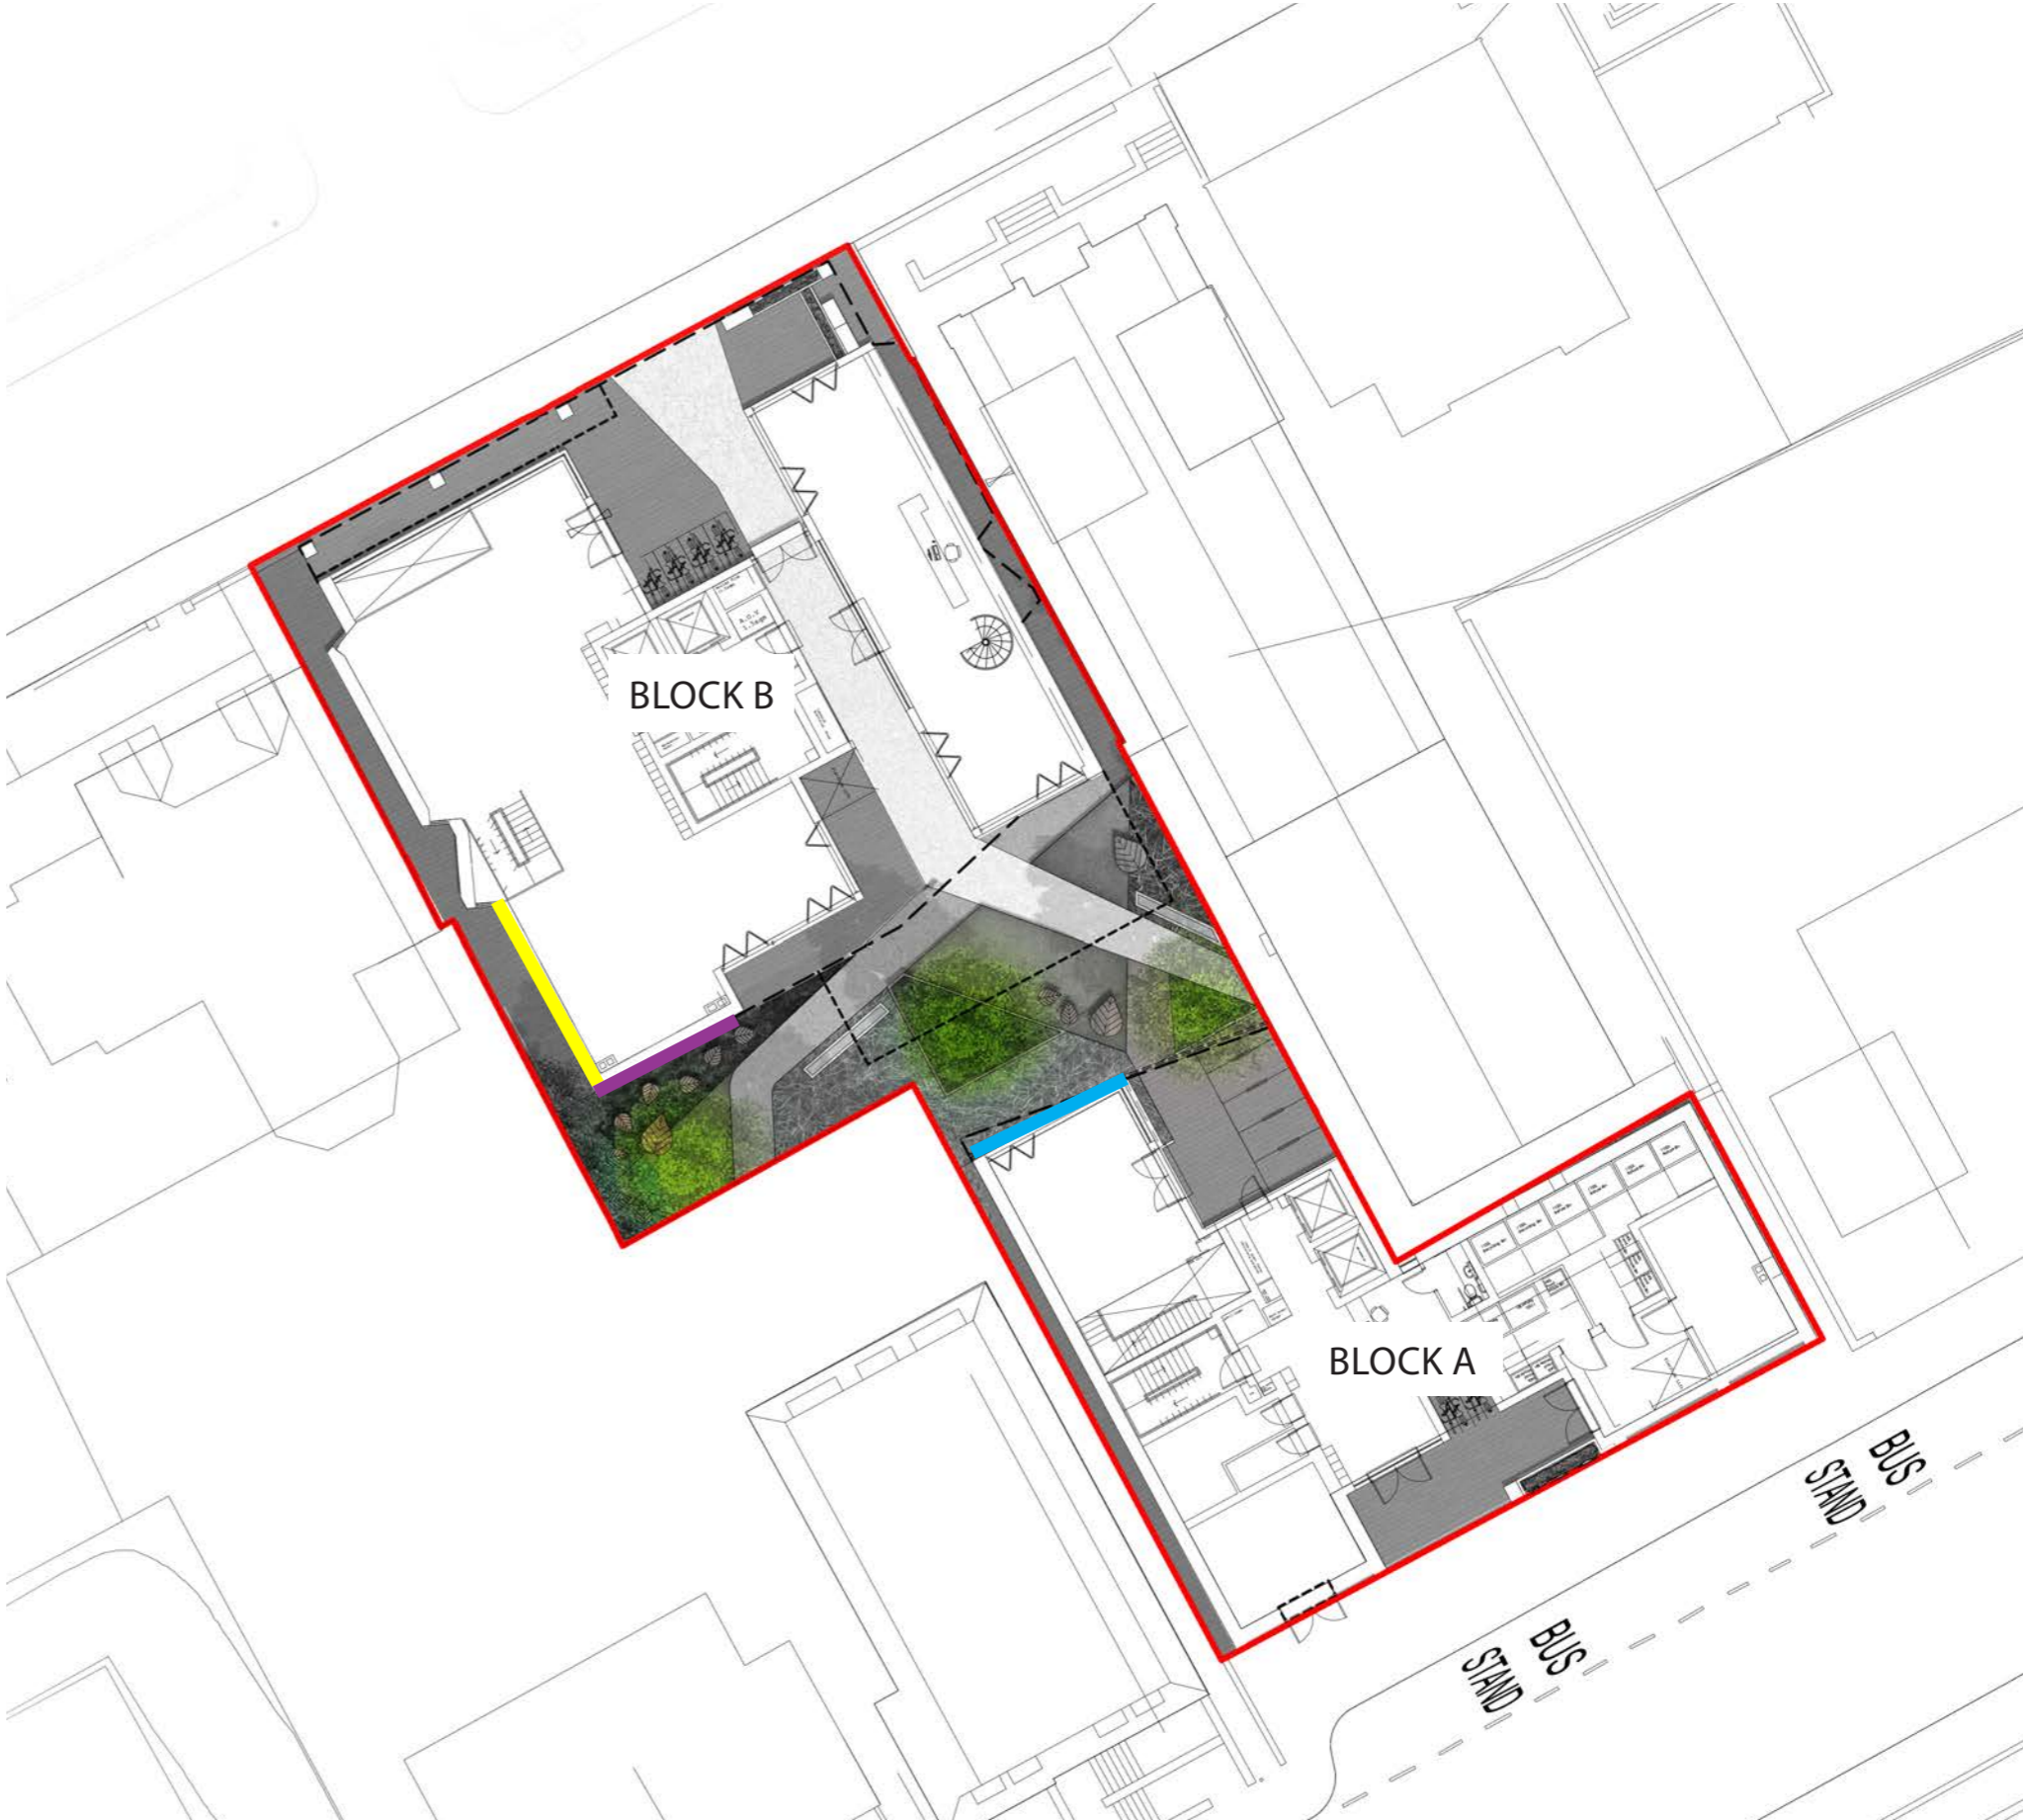
Ecology page from Design and Access Statement RRB-ETL-XX-00-RP-L-0702-DAS-14

BAT BOX
These will be able to be attached to a tree, building or pole. They need to be located away from light at 3-5m in height, facing a south-west direction.

GENERAL BIRD BOX
These will need to be made from reinforced metal around the entrance to prevent damage by squirrels, placed away from the reach of cats.

SWIFT BOX
These will need to be positioned a minimum 5m above ground, facing northwest or north easterly direction.

- 4.4. In addition, it is considered that the development proposals offer the opportunity to enhance this site for bats by creating new habitats through ecologically minded soft landscaping and through the incorporation of bat boxes to provide an increase in foraging and roosting opportunities (see appended **Ecology page from Design and Access Statement RRB-ETL-XX-00-RP-L-0702-DAS-14**).
