# LUSTRE

**RINGERS ROAD - BROMLEY**

**PHASE 1 DESK STUDY**

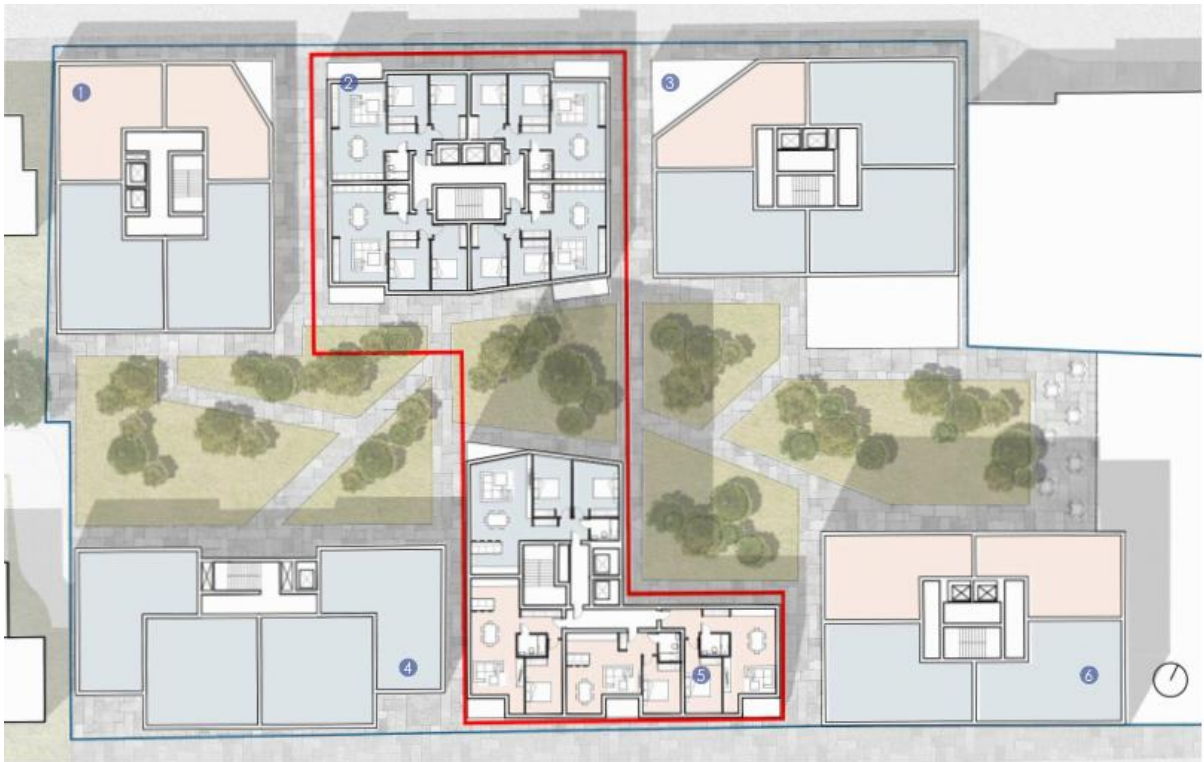
Figure 2: Proposed Site Layout

- 1.2 The site, irregular in plan, is centered at National Grid Reference 540241, 168909, and occupies an approximate area of 0.11ha as shown in Figure 1. The site currently comprises two buildings, one fronting onto Ringers Road and the other fronting onto Ethelbert Road. The Ethelbert Road property comprises residential studio apartments with a communal garden, and the Ringers Road property comprises a restaurant and bar, with the upper levels leased to a photographic studio. The site is located within a mixed commercial and residential land use area. The Client requires this Phase 1 Desk Study to support re-development works at the site. It is understood that proposals involve the clearance of the site and construction of a residential development. The proposed development will comprise two blocks of residential apartments with communal open space. Figure 2 illustrates the proposed development scheme.

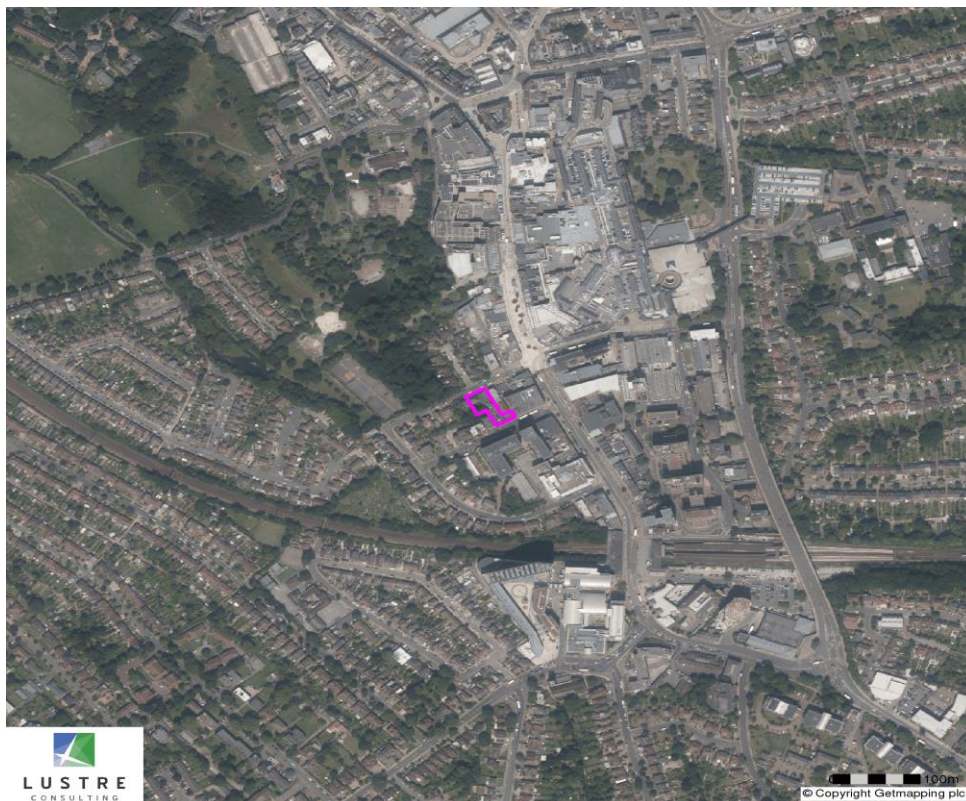
Figure 3: Aerial Photograph

- 2.3 At the time of the site walkover the site comprised two buildings, one fronting onto Ringers Road (occupying the eastern section of the site) and the other fronting onto Ethelbert Road (occupying the western section of the site).

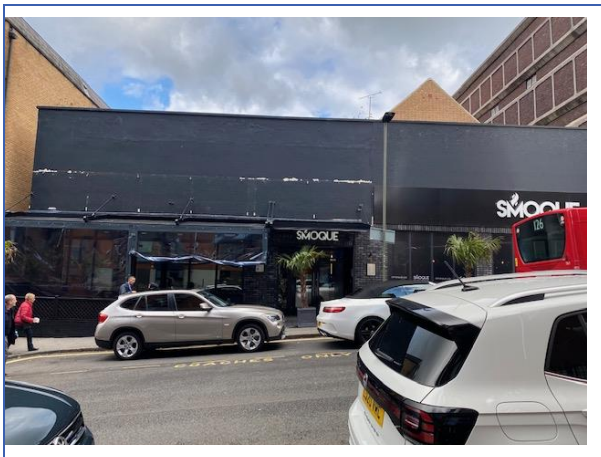
*Restaurant fronting onto Ringers Road*

- 2.5 A larger commercial property occupied the remainder of the site and is accessed via Ringers Road, adjacent to the south eastern site boundary, This property extends the full length of the site, between Ringers Road to the south and Ethelbert Road to the north and comprises a part 2 storey part 3 storey brick building, with both a pitched and flat roof .

- 2.6 A restaurant, kitchen, food storage area, including refrigerators, and bar occupied the ground floor of the property. Access across this area of the site was limited during the site walkover due to health and safety reasons. The restaurant also occupied part of the second floor of the building, with the remainder of the building understood to be let to a photographic studio.

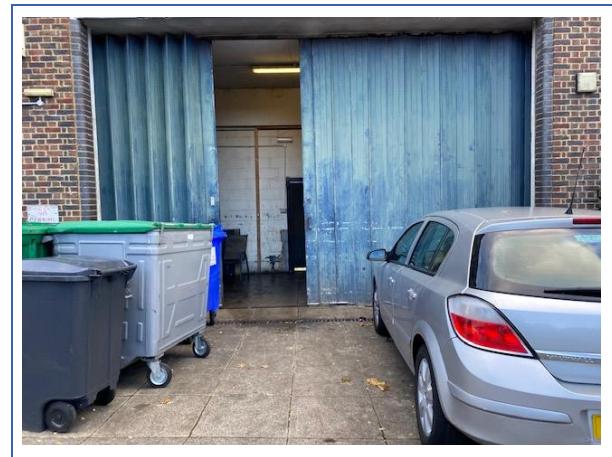
*Rear access to the restaurant from Ethelbert Road*

- 2.7 Roller doors were present to the rear of the commercial property (fronting Ethelbert Road), with this area used for receiving deliveries. A small paved area was also present, which was

used for vehicle parking and for storing waste bins. Hardstanding within this area was noted to be in good condition, with no evidence of cracking or staining.

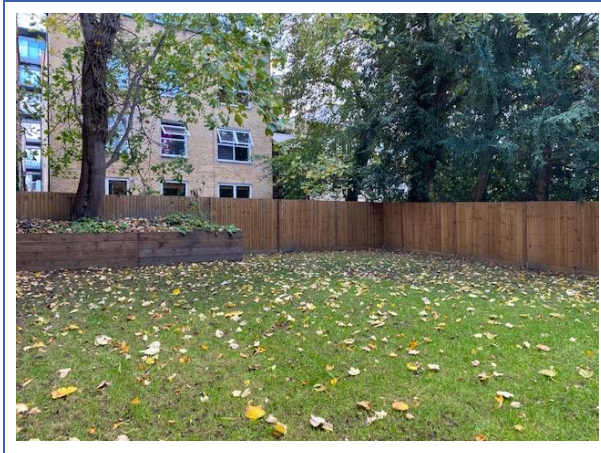
*Rear communal garden of the Ethelbert Road property*

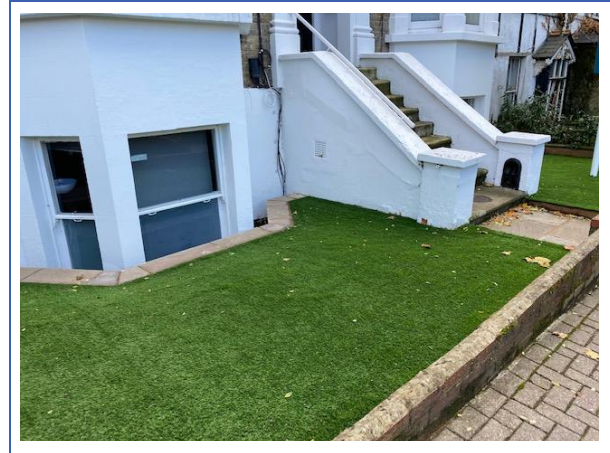
- 2.4 The Ethelbert Road property comprised a four storey residential property, split into studio apartments, including a basement level. The building was of brick construction with tiled roofing and a small strip of landscaping fronting onto Ethelbert Road, which comprised AstroTurf. An alleyway was present on the northern elevation of the property, which provided access to the rear communal garden area. Rubbish bins for domestic waste were stored on this access path, which was laid to hardstanding. The rear communal garden area comprised a patio adjacent to the residential property and an area laid to grass, with a raised plant bed present adjacent to the southern boundary. No off-street parking was included within the property footprint.

*Front garden and access to the Ethelbert Road Property*
