Technical Note

Project:	Lower Hockenden Farm		
Subject:	Study Re: Changes in Landform and Potential Deposited Materials		
Author:	Dana Montgomery		
Date:	26/09/2022	Project No.:	5216374
Distribution:	London Borough of Bromley	Representing:	London Borough of Bromley

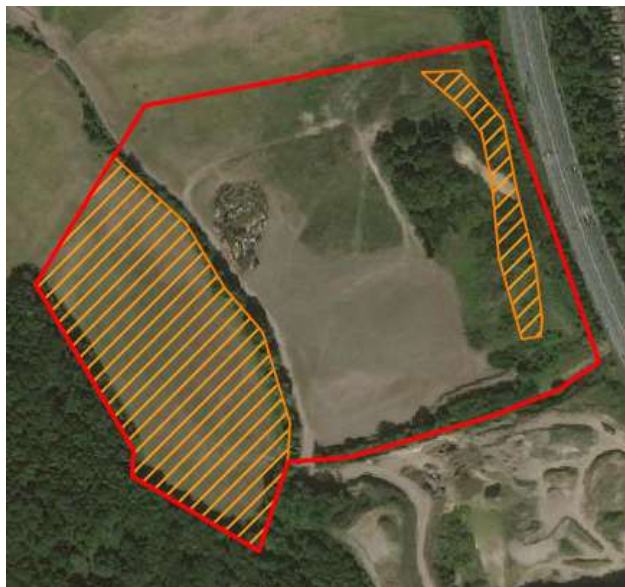
Figure-1 - Areas of Potential Material Placement (Source: Bromley Council)

Bromley Council provided Atkins with a hand-drawn sketch from the site visit and the areas of potential material placement are shown in Figure-1 below:

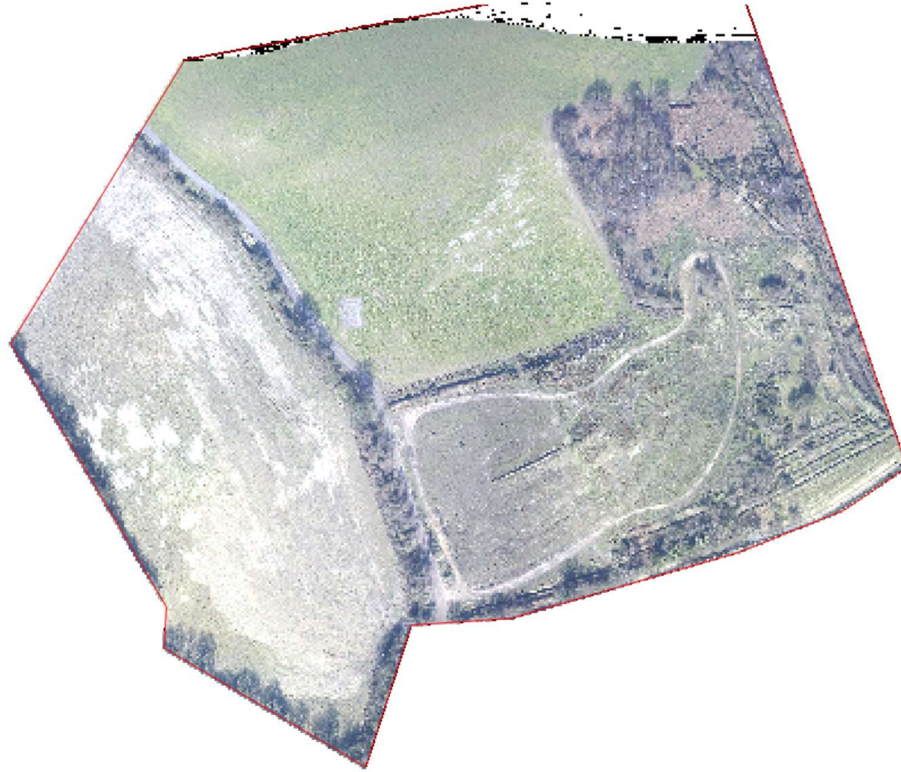
Figure-2 - 2011 Aerial Imagery (DEFRA)

Aerial imagery downloaded from the DEFRA Data Services Platform from 2011 shows the site comprising open land with some evidence of tracks and surface disturbance as shown in Figure-2:

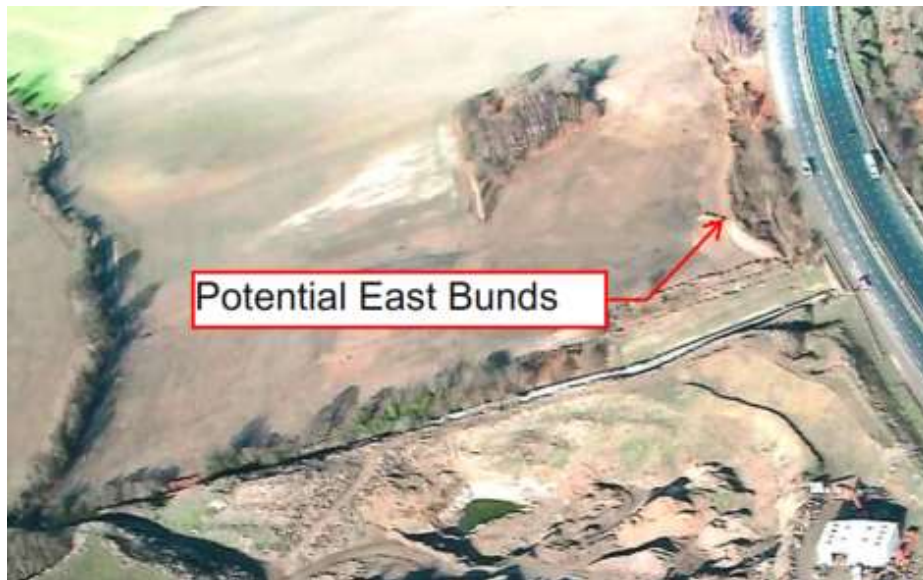
Figure-3 - Aerial Imagery (2012) Showing East Bunds (Bromley Council)

Some of the photographs indicate the establishment of bunds and surface disturbance on the site as seen in the figures below:

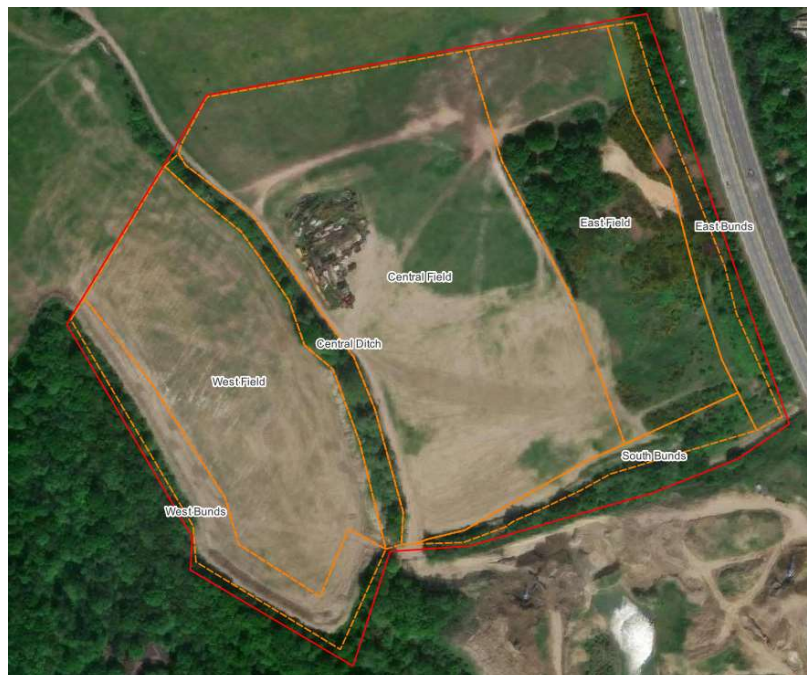
Figure-5 – ESRI Satellite Imagery (2022) Showing Equipment Storage and West Bunds (Esri, Intermap, NASA, NGA, USGS | Esri Community Maps Contributors, Esri UK, Esri, HERE, Garmin, Foursquare, GeoTechnologies, Inc, METI/NASA, USGS | Maxar, Microsoft)

Recent satellite imagery from ESRI (2022) shows the probable bunds in the West Field along with the container and equipment storage in the Central Field and surface disturbance across both the West and Central Fields:

In addition to the bunded areas, there is varying vegetation growth apparent mainly within the Central Ditch and the East Field, along with what seems to be lower lying grasses in the northern section of the Central Field. The southern portion of the Central Field appears to have had the vegetation cleared in Figure-5 above, or it has potentially been disturbed through vehicle movements.

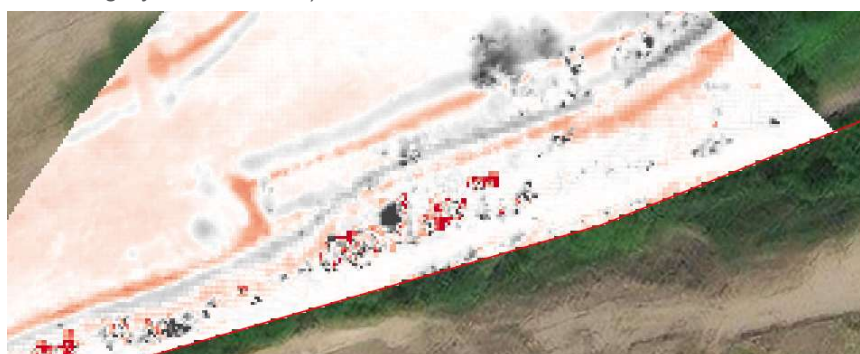
Figure-6 – 2009-2015 DSM Difference in Central Area of South Bunds

Within the central part of the South Bunds in 2009-2015, there was some evidence of materials movements on both sides of one of the tracks indicating that the landform in this area may have been flattened (red is an increase in elevation and grey is a decrease):

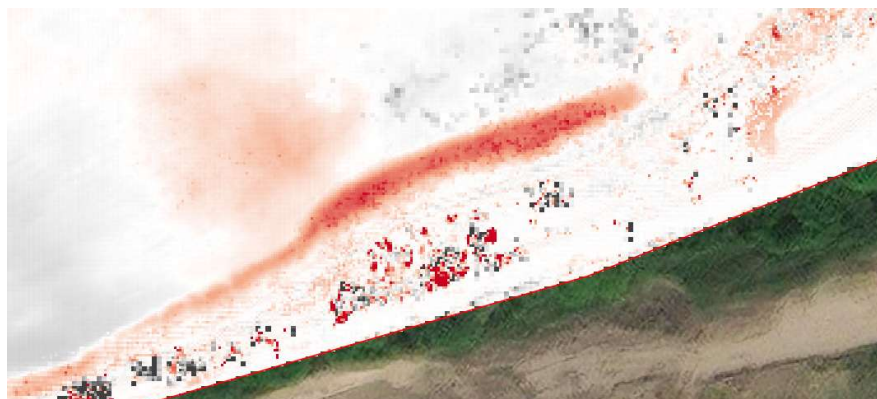
Figure-7 – 2020-2022 DSM Difference Showing Elevated Feature in South Bunds

The main difference to the South Bunds able to be ascertained from the available data was that in 2020-2022, a feature is visible which appears to be a mound of material formed to the north of a track:

Using the data from the DSMs within this area, one point is at an elevation of 70.7 m in 2020, whereas the same point in 2022 shows an elevation of 72.7 m.

The South Bunds have been subject to changes in vegetation presence and the existence of tracks within this area, which both would have an impact on the above volume calculations. When a smaller area of the wider South Bunds is assessed – focussing on the linear elevated feature visible in Figure-7 and Figure-8 – the indicative volume change of this feature only is +1,910 m³.

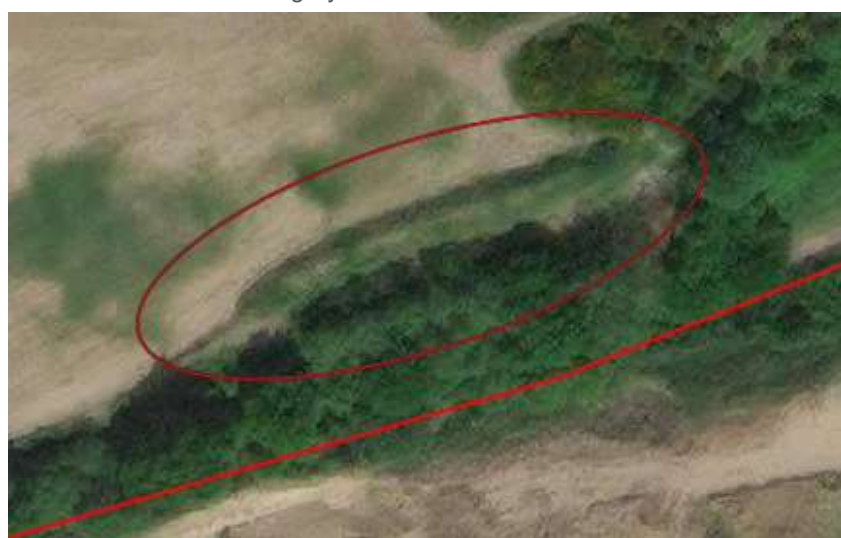
Figure-8 - Aerial Imagery Showing Elevated Feature in South Bunds (Esri, Intermap, NASA, NGA, USGS | Esri Community Maps Contributors, Esri UK, Esri, HERE, Garmin, Foursquare, GeoTechnologies, Inc, METI/NASA, USGS | Maxar, Microsoft)

This also appears to be visible in aerial imagery:

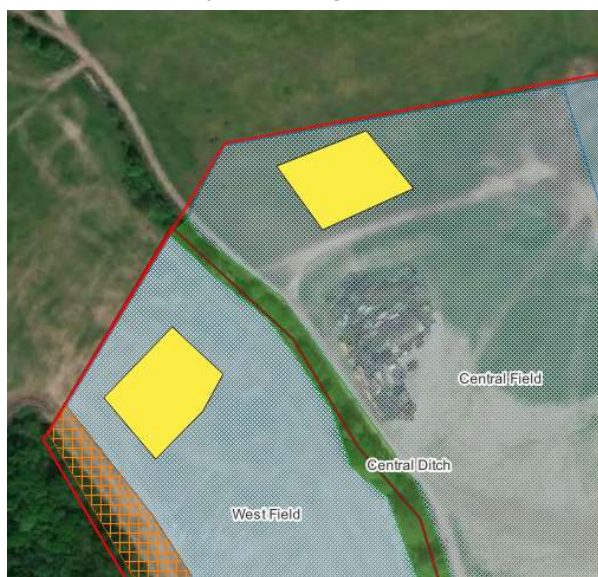
Figure-9 - West Field Check and Central Field Check Locations

The locations of the check areas are shown in yellow in Figure-9.

The two areas within the northern sections of the West Field and Central Field were extracted in the same way and indicative volume changes were calculated and provided in Table-3.

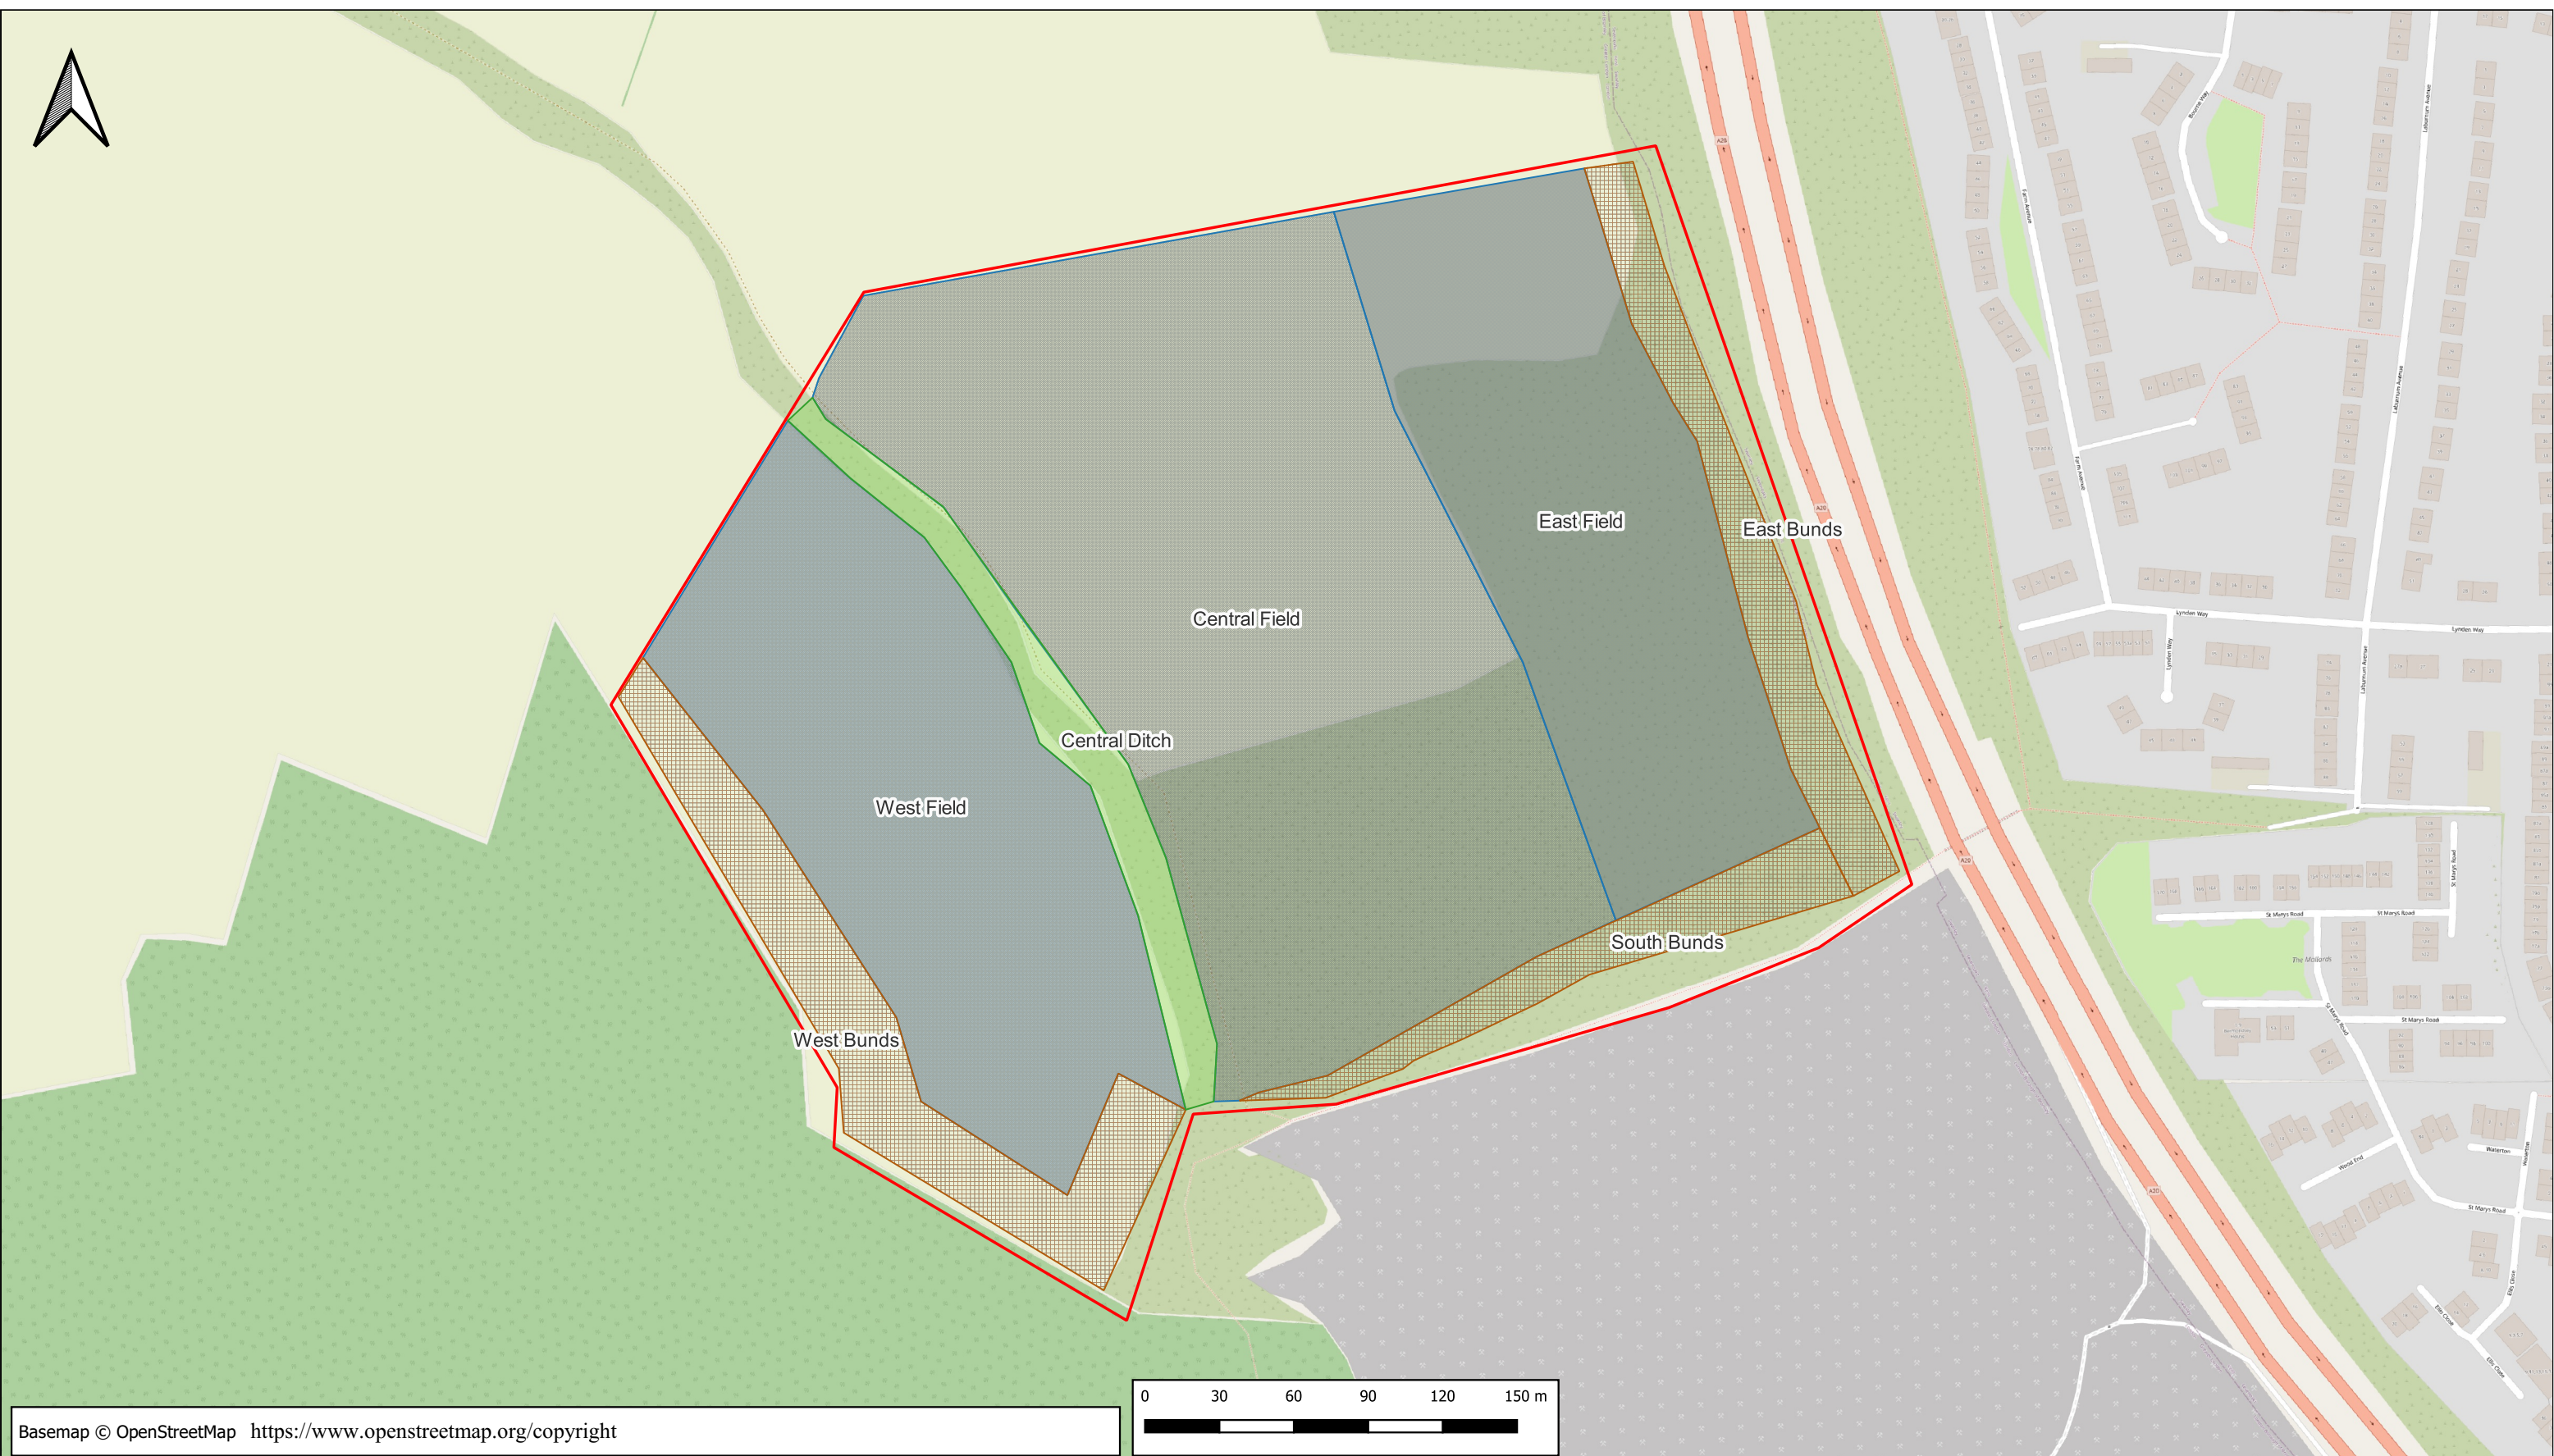
Project Title				Hockenden Farm			
Drawing Title				Reference Zones			
Drawing Number		Project		Originator		Volume	
Drawing 2							
Original Size	Scale	Type	Role	Number	Sheet	Rev	
A3	1:2500	Ref. No	5216374	1 of 1	01

For the purposes of discussion within this technical report, the site has been divided into seven Zones and given reference names as shown on Drawing 2 in Appendix A:

- West Bunds
- West Field
- Central Ditch
- Central Field
- South Bunds
- East Field
- East Bunds

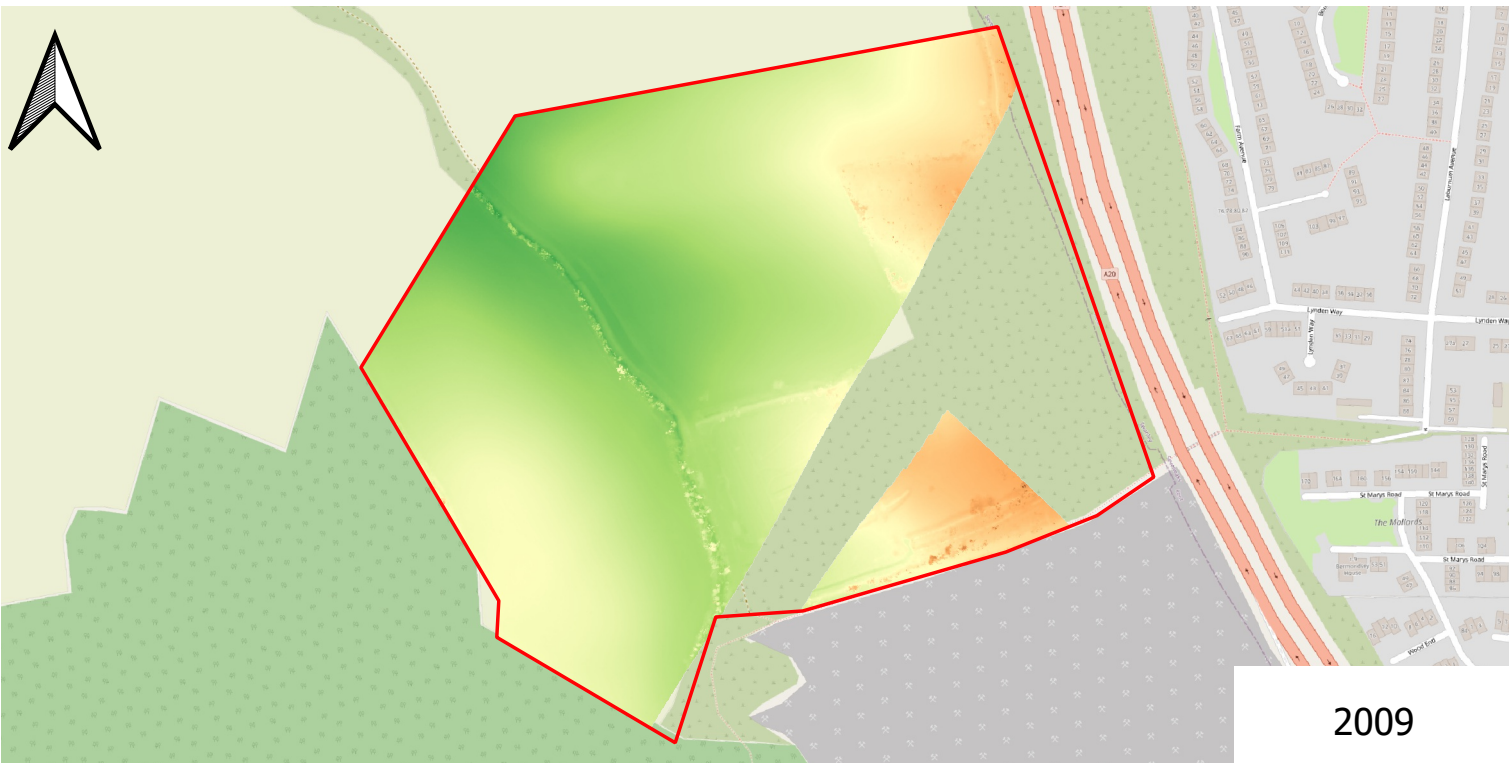
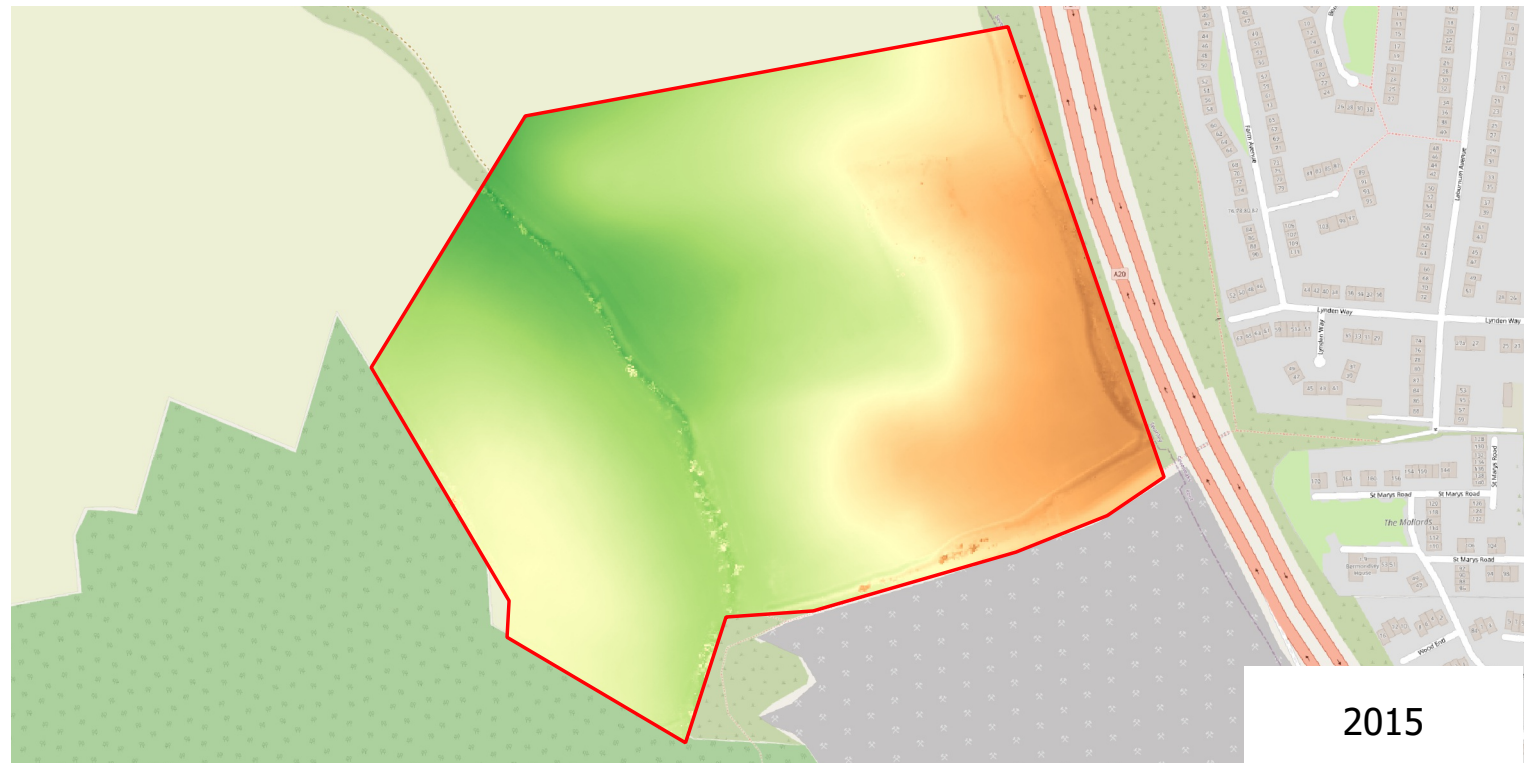
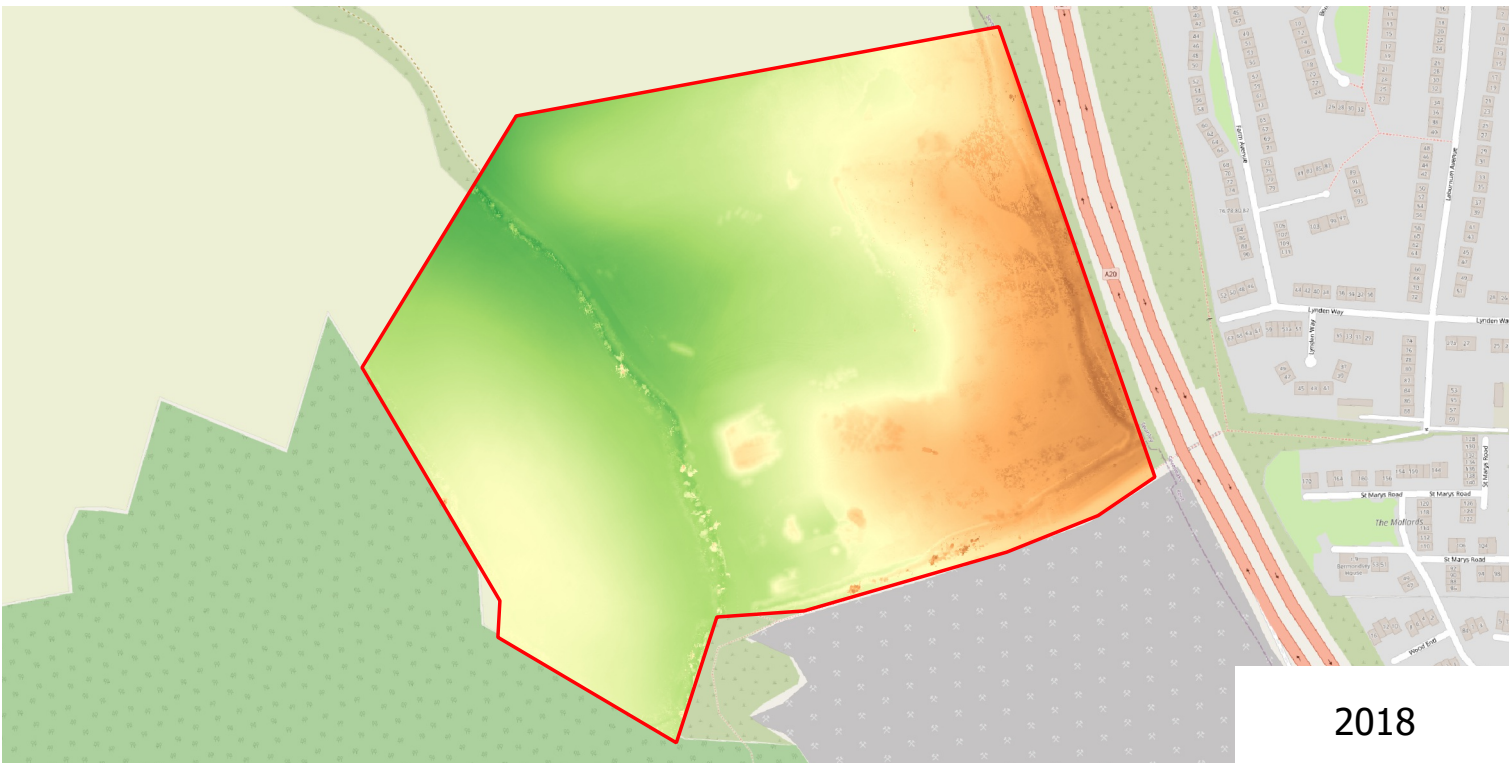
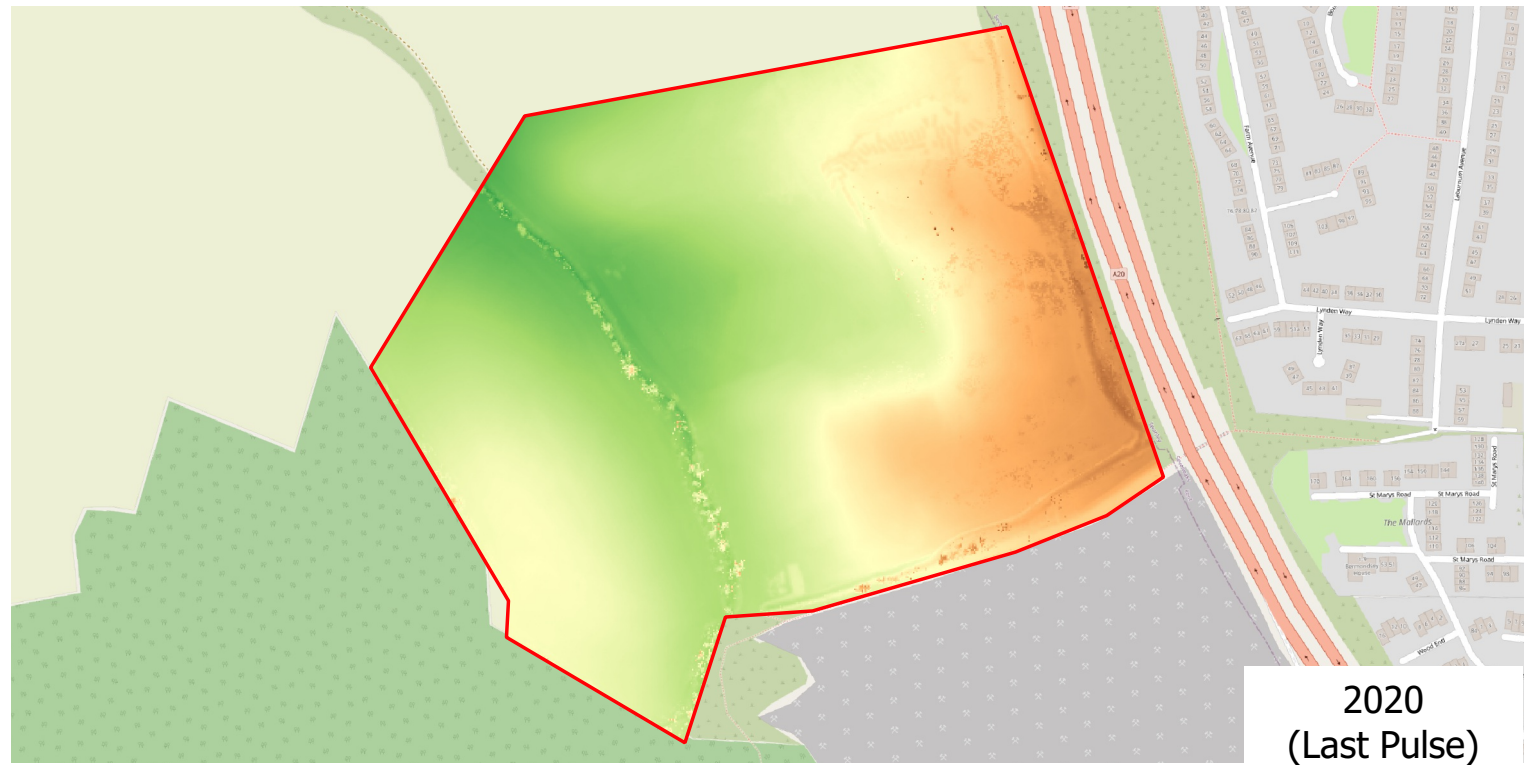
Project Title		Hockenden Farm	
Drawing Title		LIDAR DSM Data (2009, 2015, 2018, 2020)	
Client		Bromley Council	
Drawing Number	Project	Originator	Volume
Drawing 3		Drawing 3	
Original Size	Scale	Type	Role
A3	1:5000	Ref. No	Number
		5216374	1 of 1
			Rev 01

Drawing 3 in Appendix A provides a side-by-side comparison of the DSMs from 2009-2020 and Drawing 4 provides a closer view of the DSM from 2022 as provided by Bromley Council; brown indicates a higher elevation than green.

While the 2009 data is only partially available due to gaps in the original collection of the LIDAR data, the South and East Bunds are visible as elevated features in all DSMs from 2009-2020; the landform of the south-east area of the site from before 2015 is unable to be determined

In addition, in the 2018 DSM shows further elevated features/potential mounds in the southern part of the Central Field – these are then shown as removed (i.e. a decrease in elevation) in the 2020 DSM.

Note: 2020 utilised last pulse LIDAR DSM data as more likely to return ground level

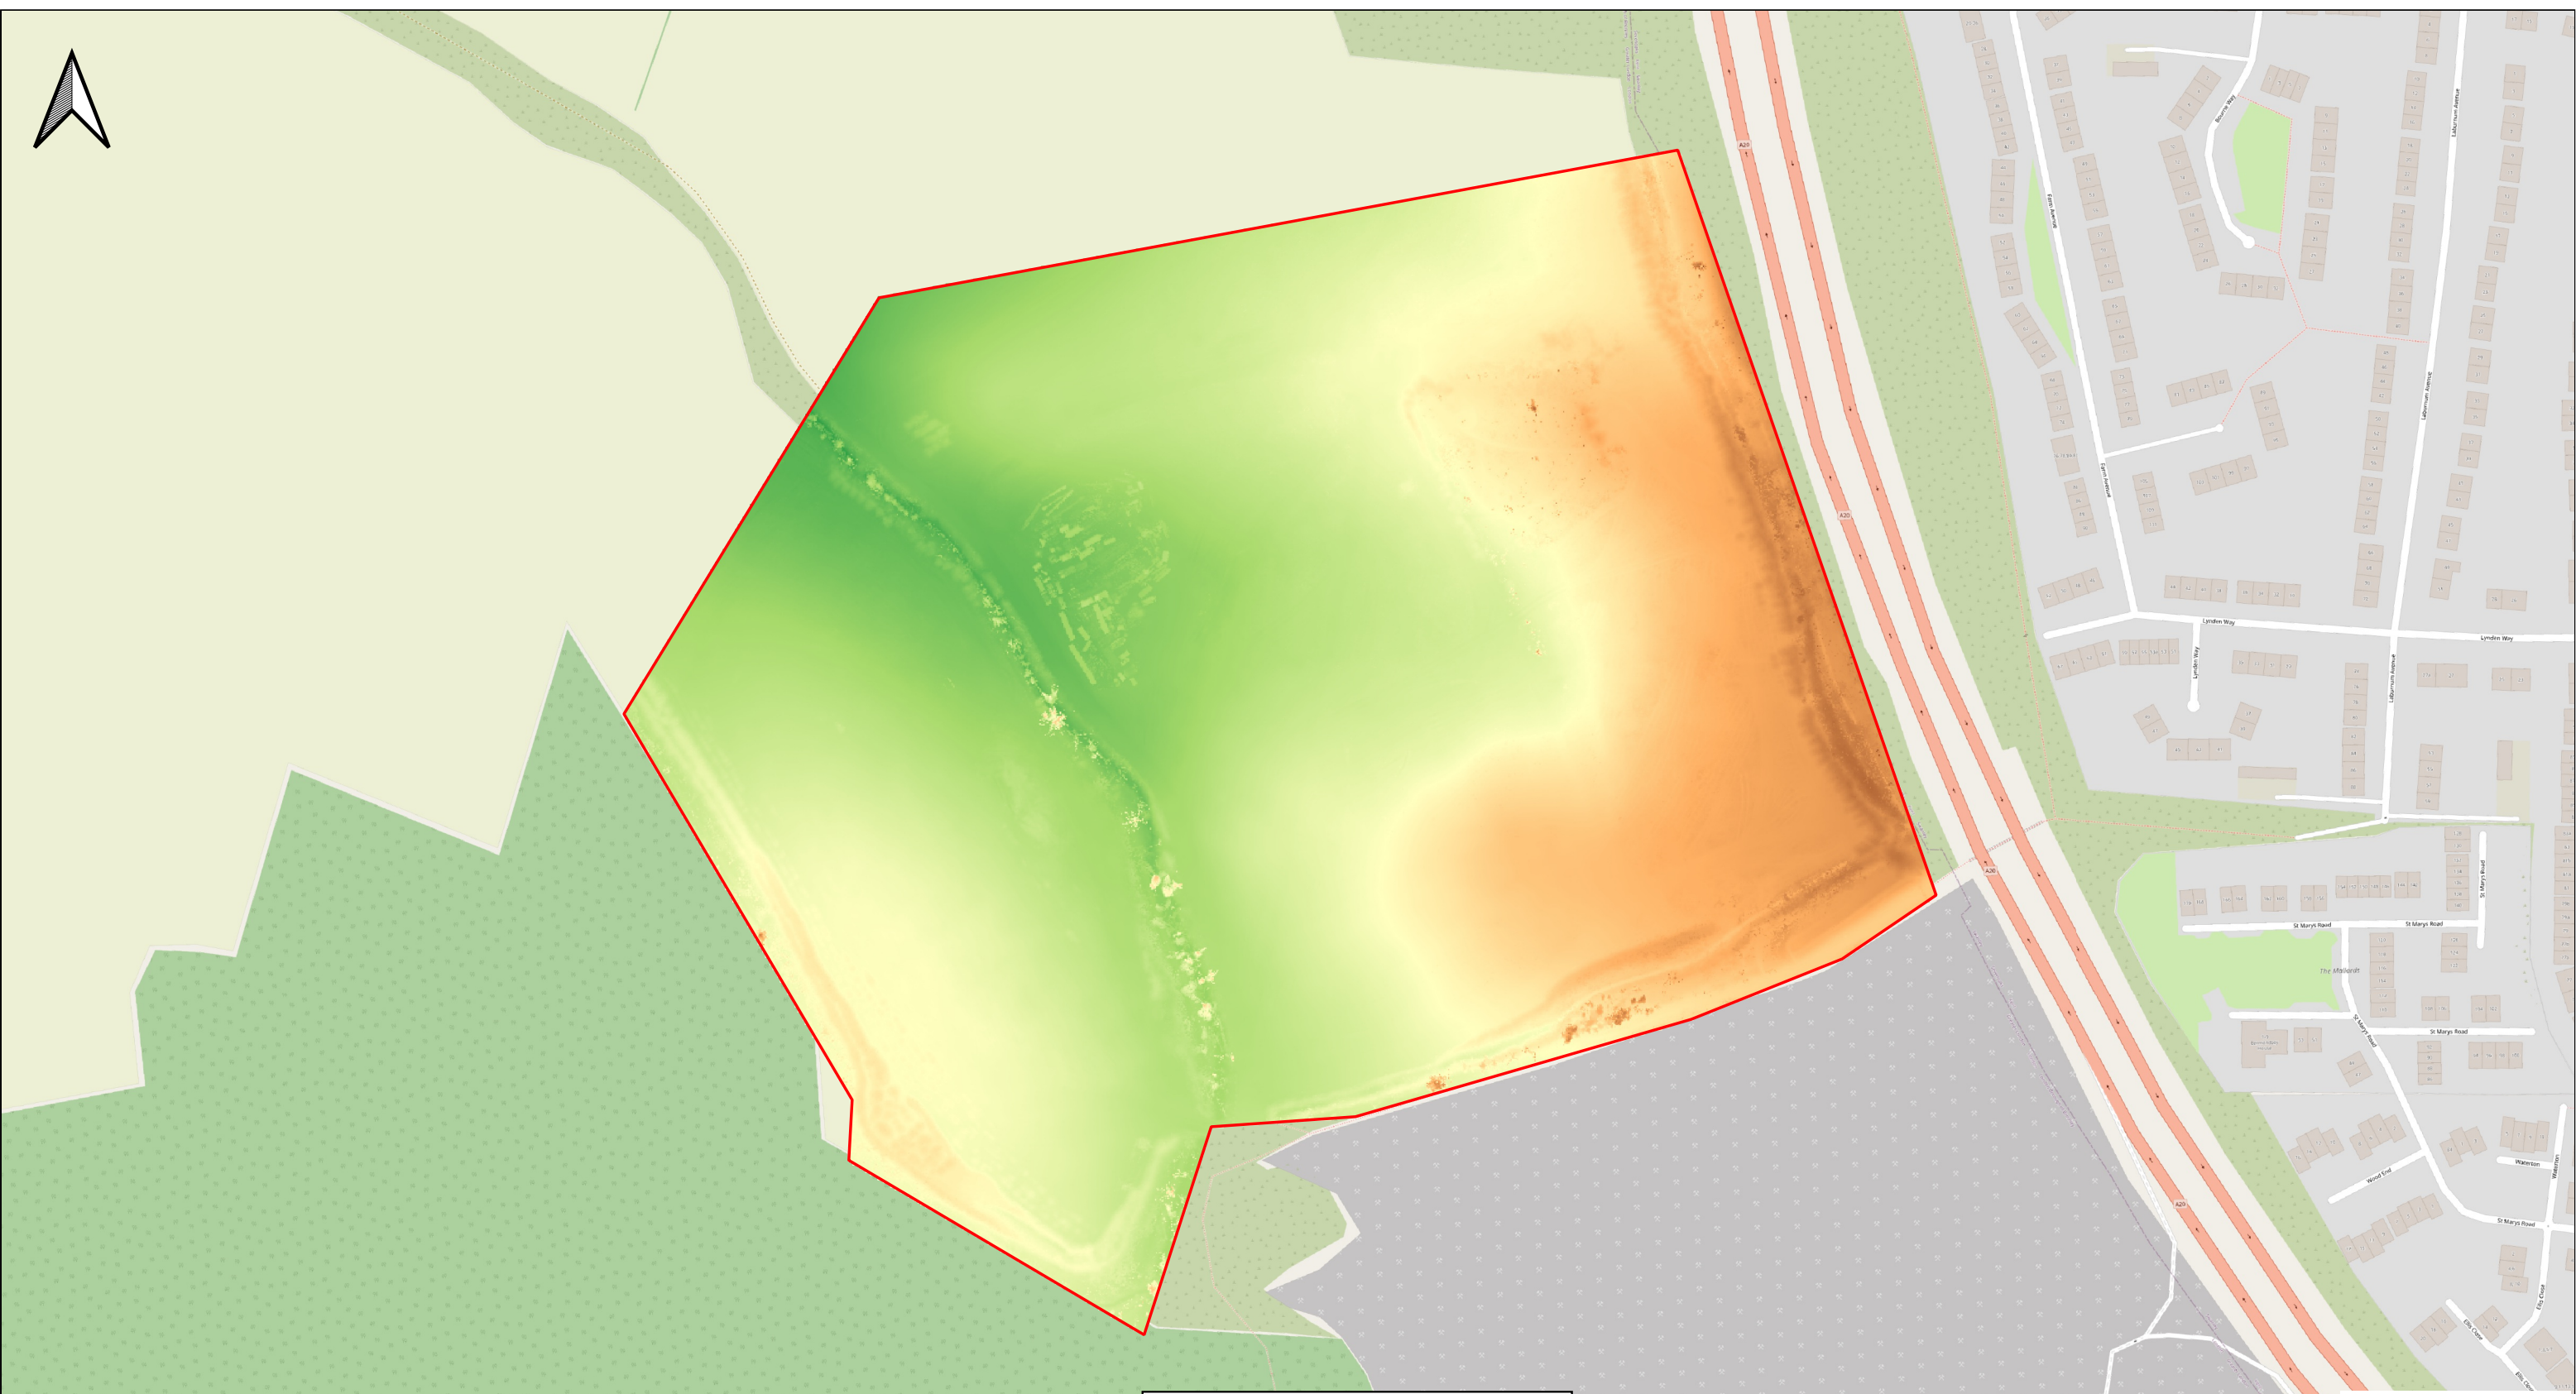
Project Title					
Hockenden Farm					
Drawing Title					
LIDAR DSM Data (2022)					
Drawing Number					
Project	Originator	Volume			
Drawing 4					
Original Size	Scale	Type	Role	Number	
A3	1:2500	Project Ref. No	5216374	Sheet	1 of 1
				Rev	01

In Drawing 4 the West Bunds are now also visible, and the South and East Bunds appear to have potentially been augmented with further deposited material inside the original bund features. The area of equipment and container storage is also now visible in the Central Field.
