Appendix B. Site Walkover Record

SITE DIARY

Atkins Project Ref.	5216374	Record No.	1
Project Name	Hockenden Farm, Hockenden Lane, Swanley		
Project stage	Site Walkover		
Date/time of visit	25/07/2022		
Site visit undertaken by	Zita Czinke	Weather conditions	Overcast, warm
Plant/personnel on site/visitors	David Bord – London Borough Bromley

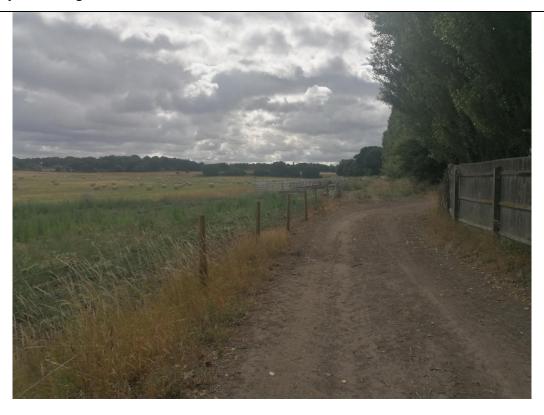
Access to fields through public footpath/byway from Hockenden Lane.

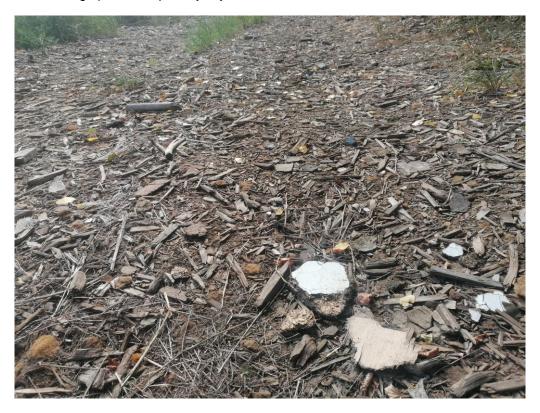
- Access through public footpath /dirt road/byway from Hockenden Lane, opposite Pearson TQ
 Construction Academy. Farm access road created parallel to the public footpath (levelled with
 woodchip material mixed with anthropogenic material including of some insulation materials).
 Frequent hard plastic and soft plastic of various sizes encountered and occasional metal of various
 sizes. (Metal spring of approx 10 cm in length, nails of approximately 1-3cm of length. Occasional
 fragments of cables.

General overview of wood chipping used to level / create farm access road which runs parallel to the public footpath / byway. Wood chipping is mixed with various material.

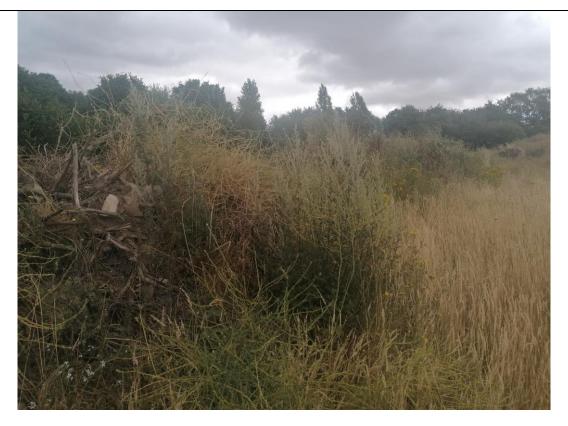
- Mounds along the A20, approx 1.5 2.0 m height, along east boundary of site consist of various branches, wood fragments, angular to subangular concrete boulders of various sizes, soft plastic and processed wood (plasterboard). Frequent wood chipping. Some fragments of wood have paint on them on one side.

General overview of mound along A20 (East Bunds). View from north to south.

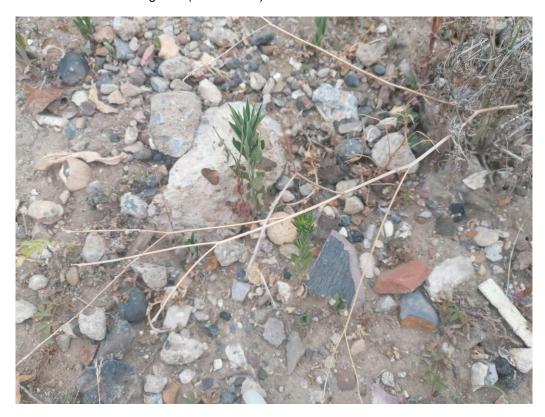
A few loads – approximate excavator bucket size of subangular to subrounded fine to coarse of weathered chalk gravels and subangular boulders of chalk. Rare subrounded fine to coarse gravel of flint.

Occasional hard plastic approximately 3 to 10 cm in diameter, occasional metals, wiring, fragments/sharps of glass.

Broken tiles of various sizes. Boulders of concrete of various sizes. Fragments of airbricks and pieces of insulation material of various sizes. Anecdotal information by council suggest that these mounds appeared in the last few years.

General overview of material within the mounds along A20 (East Bunds).

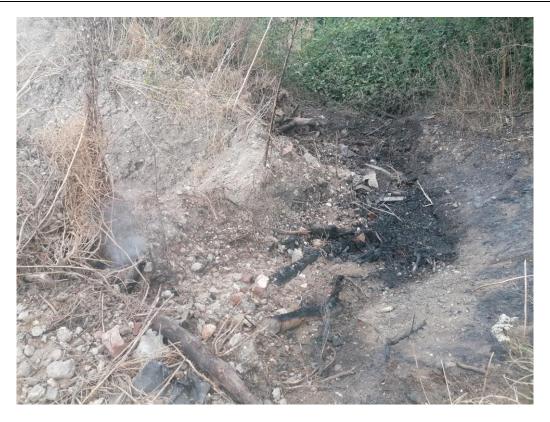
- A burning pit near the tunnel (A20 under path, southeast corner of site, near public footpath) was still smoking.
- Over the stream, southwest field of the site, there are Made Ground mounds 1.5 to 2.0 m of height of gravelly material including of subangular to subrounded fine to coarse of siliceous, ballast including of granite and calcareous, frequent brick, concrete. Occasional ceramic tiles approximately 1-5 cm in diameter, fragments of clay pipe approximately 2-4 cm in diameter, metals approximately 1-4 cm in diameter, fragment of air brick pieces approximately 1-3 cm in diameter, wood chipping.

Burnt area in the southeast corner of site (East Field). May be used as a burning pit. Note that it is still smoking at the time of the site visit.

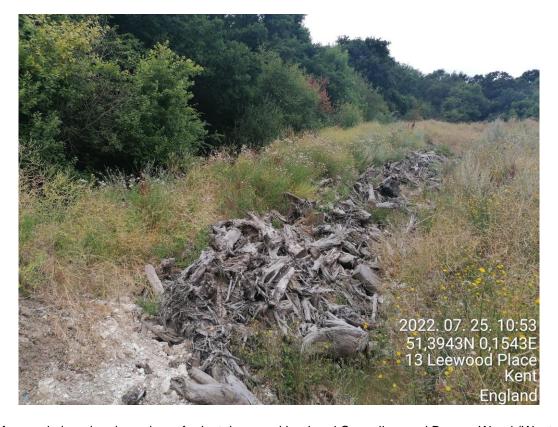
View of mound placed on boundary of privately owned land and Council owned Bourne Wood (West Bunds). With timestamp.

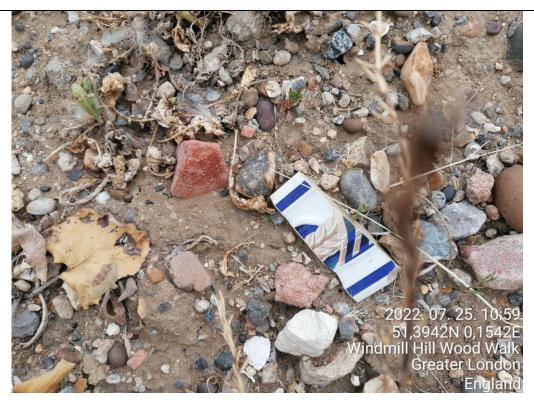
- Originally an enforcement notice was issued for these mounds to be removed and cleared but was cancelled after it was realised that more investigation may be needed for larger amount of made ground placed on this field.
- Natural topsoil in Bourne Wood appears as light brown slightly gravelly silty fine and occasionally medium sand. Gravel is subrounded fine to coarse of siliceous nature.
- The ground level in the neighbouring woodland seems to be lower, may be indication of where original ground level can be expected on the south-western field.
- Other notes: Quarry entrance gate was open.

General view of Made Ground encountered covering the south of the southwestern field (West Field). Consisting of light greyish brown silty sands with multicoloured very angular to subrounded fine to coarse of gravels of siliceous, chalk, calcareous, ballast, brick and concrete. Occasional tiles. With timestamp.

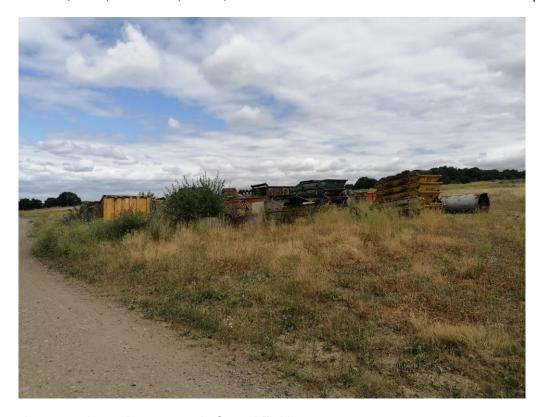
View of equipment and container storage in Central Field

- Enforcement notice has been issued by the Council to remove metal containers and metal quarry equipment from the central field.
- No ground investigations have been carried out on site. No publicly available historical borehole
 data available on BGS website. Bedrock is Thanet Sand according to BGS website. No superficial
 deposit according to BGS website.

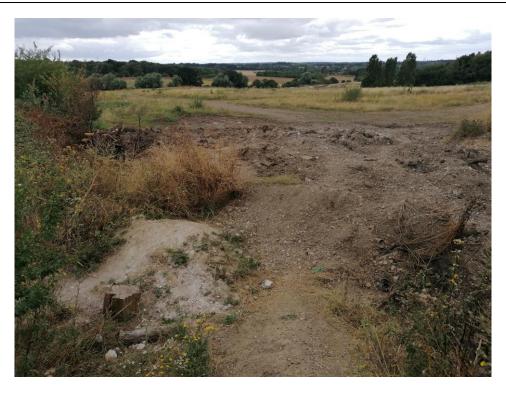
View from south-east corner of East Field showing disturbed ground with evidence of non-natural materials at the surface

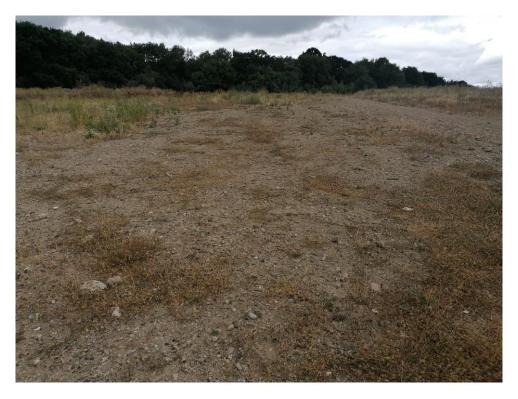
View of West Field showing disturbed ground

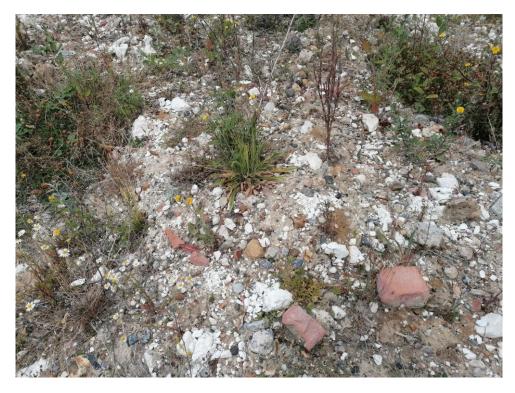
Detail of general Made Ground present within the bunds across the site with sandy gravelly matrix
