DAYLIGHT, SUNLIGHT & OVERSHADOWING

Ringers Road

Produced by XCO2 for Ringers Road Properties Ltd.

May 2024

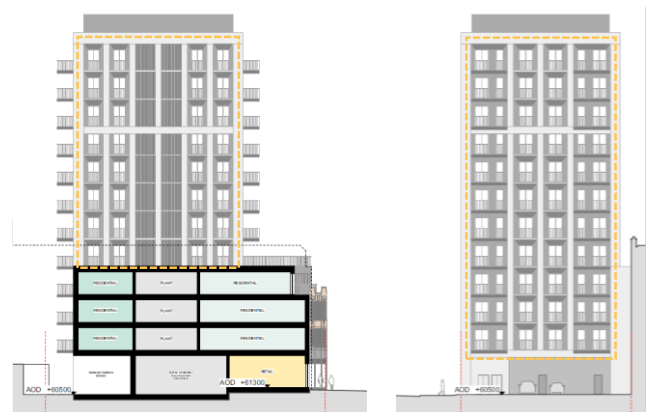
Figure 2: 66-70 High Street south elevation (L) and west elevation (R) windows.

This consented residential building will be located to the east of the proposed development. Figure 2 shows the assessed windows. The model for this consented building was developed based on the planning submission with reference 19/04588/FULL1.

The analysis found that 56 of the 136 assessed windows passed the 25-degree plane test. Of the remaining 80 windows, 33 were found to achieve a VSC greater than 27% and pass the NSL test, and 6 more were found to achieve a relative VSC greater than 80% when compared to the existing value and pass the NSL.

Of the remaining 41 windows, 41 were found to not meet the BRE criteria for VSC but pass the NSL test..

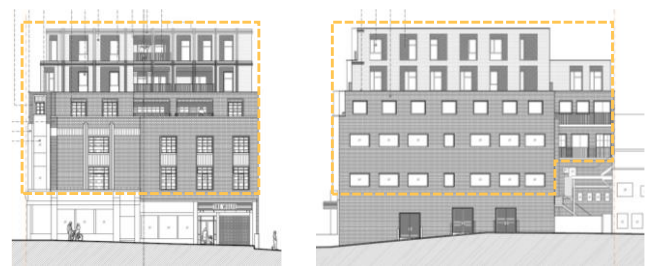
Figure 4: 62 High Street north elevation (L) and west elevation (R) windows

This consented residential building will be located to the south of the proposed development. Figure 4 shows the assessed windows. The model for this consented building was developed based on the planning submission with reference 21/04667/FULL1.

The analysis found that 82 of the 153 assessed windows passed the 25-degree plane test. Of the remaining 72 windows, 16 were found to achieve a VSC greater than 27% and pass the NSL test, and 34 more were found to achieve a relative VSC greater than 80% when compared to the existing value and pass the NSL.

Of the remaining 22 windows, 10 were found to meet BRE criteria for VSC but not the NSL test, and 6 were found to not meet the BRE criteria for VSC but pass the NSL test.

The remaining 6 windows were found to be achieving a VSC below 15% largely due to these windows having enjoyed a relatively significant amount of daylight in the existing context.

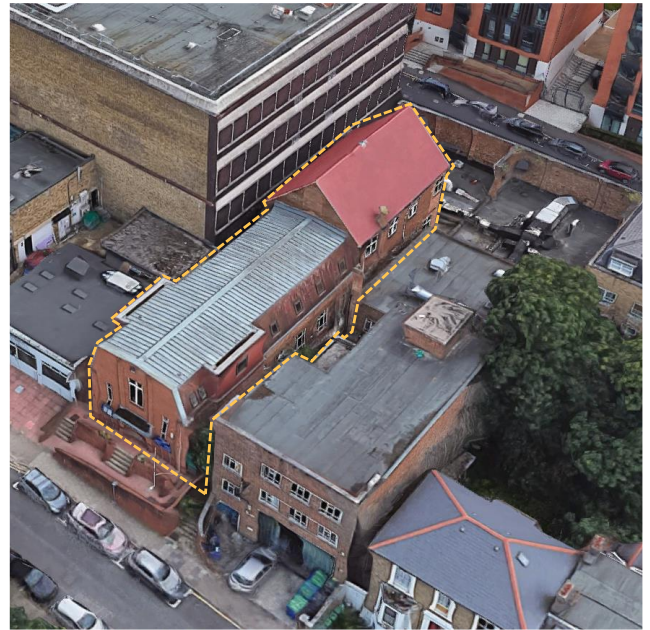
Figure 10: Bromley Temple windows.

This building is located to the east boundary of the proposed development. Figure 10 shows the assessed windows. The rooms were tested for NSL.

The remaining 11 windows were found to be achieving a VSC below 15% largely due to these windows having enjoyed a very significant amount of daylight in the existing context.

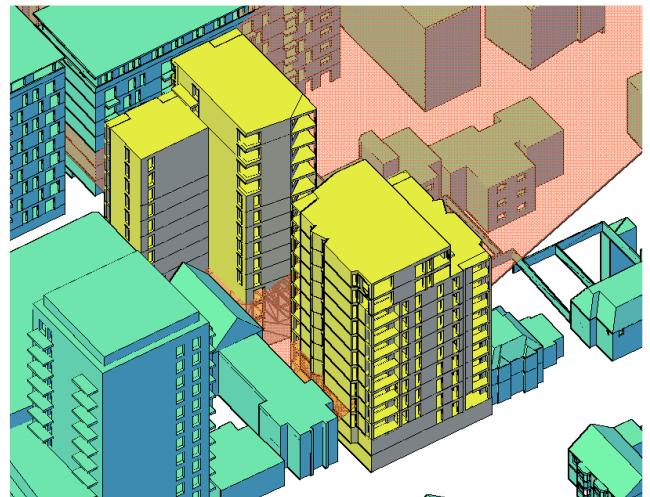
Figure 11: Bromley Temple 25-degree plane.

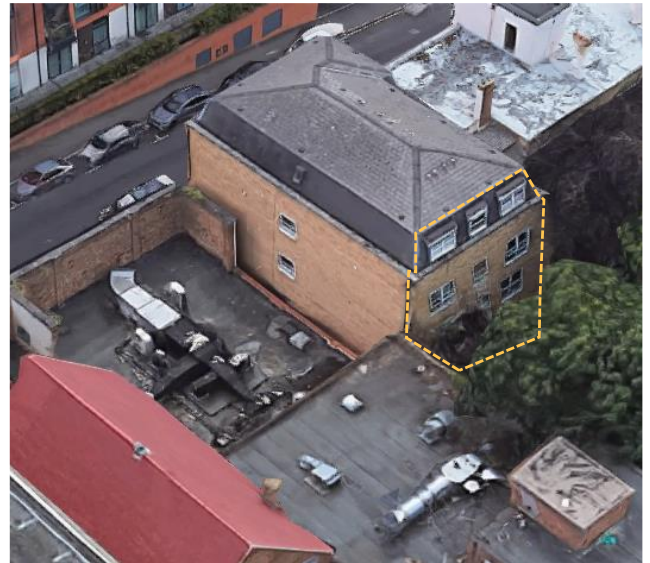
Figure 12: Simpsons Place windows.

This building is located to the west boundary of the proposed development. Figure 12 shows the assessed windows. The rooms were tested for NSL.

The remaining 5 windows were found to be achieving a VSC below 15% largely due to these windows having enjoyed a very significant amount of daylight in the existing context.

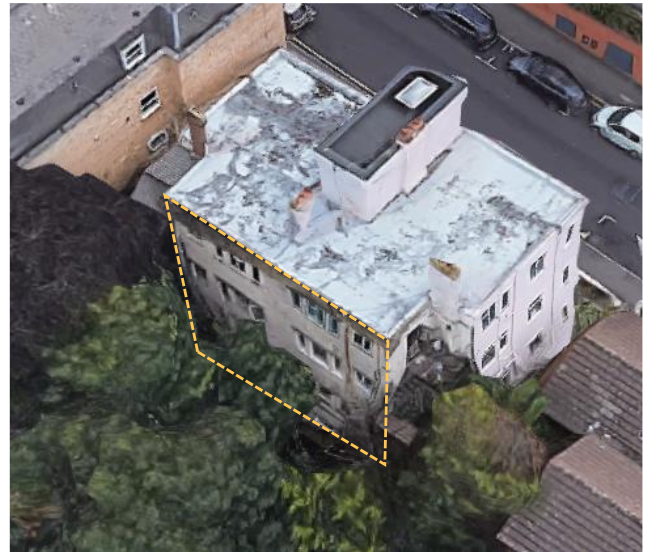
Figure 14: Ringers Court windows.

This building is located to the west of the proposed development. Figure 14 shows the assessed windows. The rooms were tested for NSL.

The remaining 2 windows were found to achieve a VSC greater than 20% with the proposed development in place, and whilst this is strictly below the BRE criteria, it is still considered to be a good level of daylight for an urban environment.

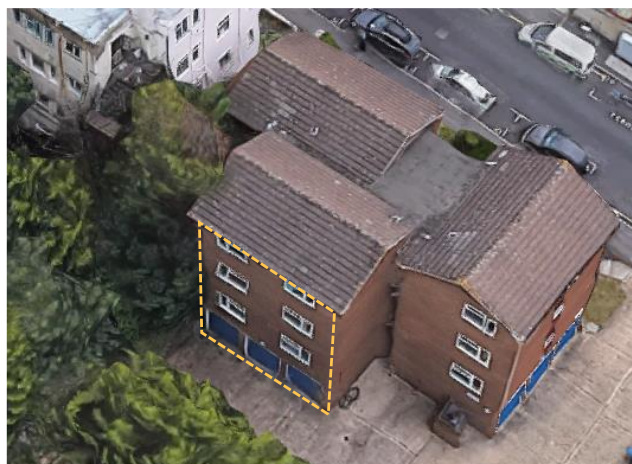
Figure 16: Harestone Court windows.

This building is located to the west of the proposed development. Figure 16 shows the assessed windows. The rooms were tested for NSL.

The analysis found that none of the 6 assessed windows passed the 25-degree plane test. Of the remaining 6 windows, 6 were found to achieve a VSC greater than 27% and pass the NSL test.

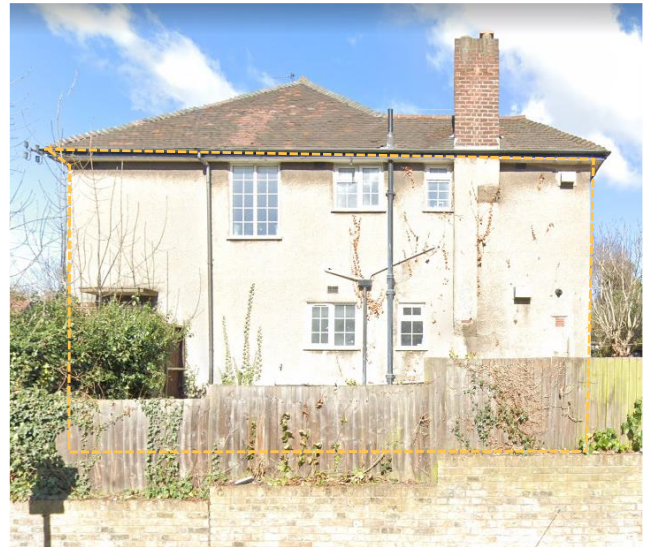
Figure 18: 35-36 Ethelbert Close windows.

This building is located to the north of the proposed development. Figure 18 shows the assessed windows. The rooms were tested for NSL.

Of the remaining 10 windows, 10 were found to not meet the BRE criteria for VSC but pass the NSL test.

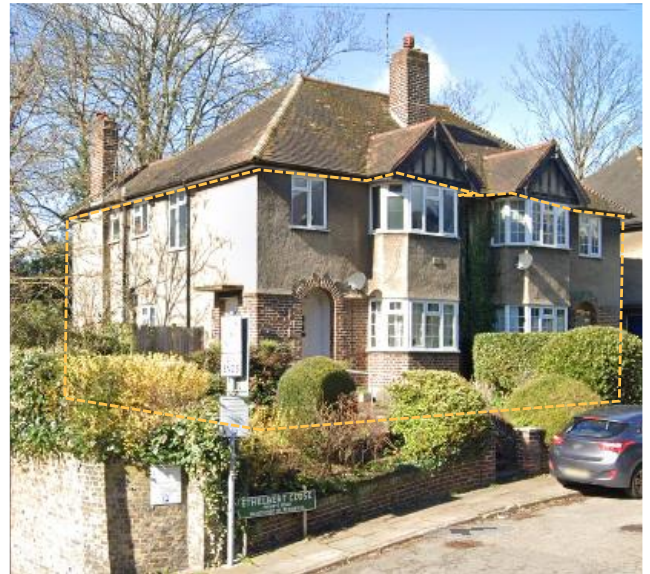
Figure 20: 1-2 Ethelbert Close windows.

This building is located to the north of the proposed development. Figure 20 shows the assessed windows. The rooms were tested for NSL.

Of the remaining 2 windows, 2 were found to achieve a VSC greater than 20% with the proposed development in place, and whilst this is strictly below the BRE criteria, it is still considered to be a good level of daylight for an urban environment.

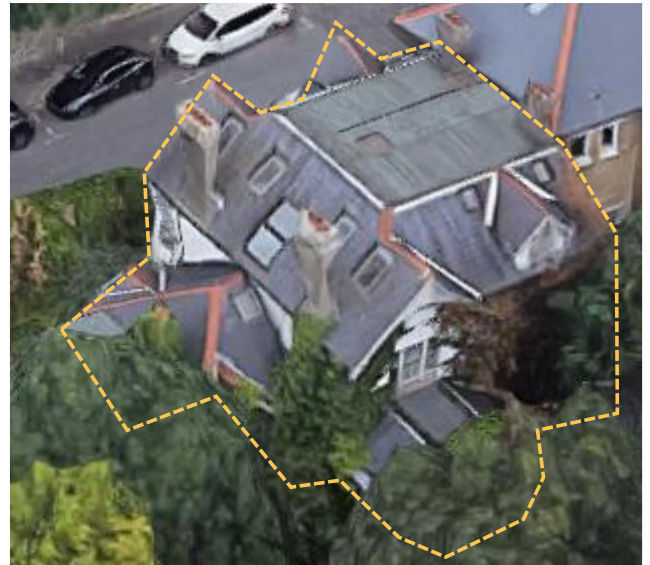
Figure 22: 7 Ethelbert Court windows.

This building is located to the west of the proposed development. Figure 22 shows the assessed windows. The rooms were tested for NSL.

Of the remaining 5 windows, 5 were found to not meet the BRE criteria for VSC but pass the NSL test.

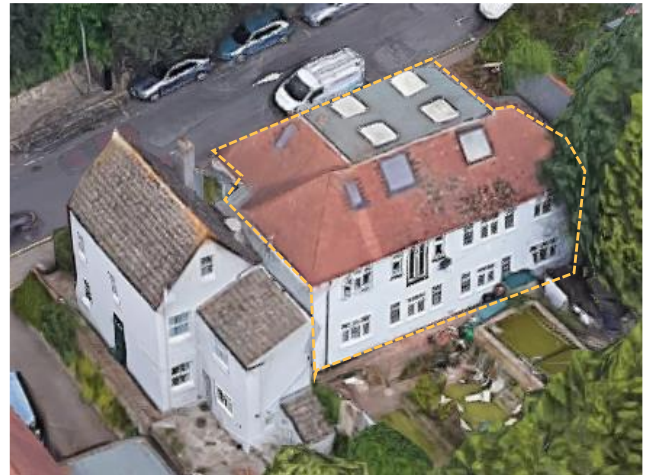
Figure 24: 1 Ethelbert Court windows.

This building is located to the west of the proposed development. Figure 24Figure 30 shows the assessed windows. The rooms were tested for NSL.

The remaining 1 window was found to not meet the BRE criteria for VSC but pass the NSL test.

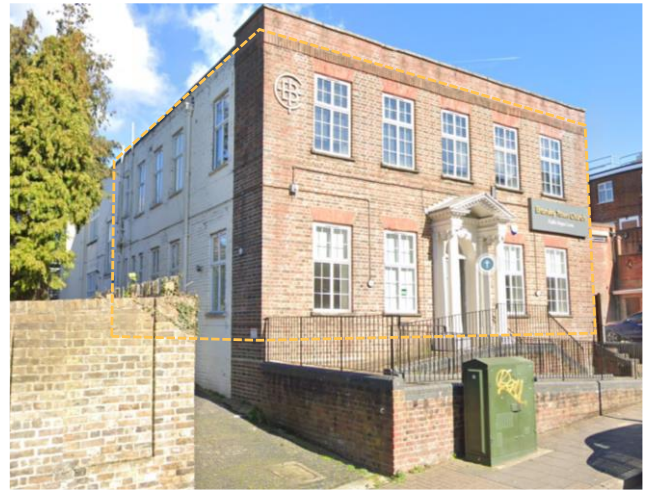
Figure 26: 2 Ethelbert Road windows.

This building is located to the west of the proposed development. Figure 26 shows the assessed windows. Since there was no publicly available information on the building’s internal layout, the rooms were not tested for NSL.

The remaining 2 windows were found to be achieving a VSC below 15% largely due to these windows having enjoyed a very significant amount of daylight in the existing context.

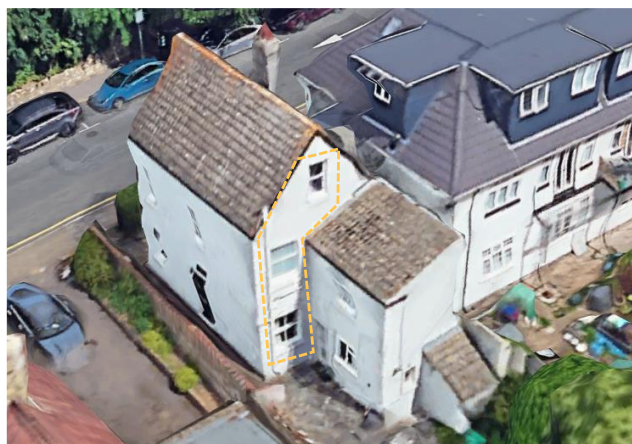
Figure 28: 11 Ethelbert Road windows.

This building is located to the west of the proposed development. Figure 28 shows the assessed windows. Since there was no publicly available information on the building's internal layout, the rooms were not tested for NSL.

The analysis found that none of the 3 assessed windows passed the 25-degree plane test. Of the remaining 3 windows, 2 were found to achieve a VSC greater than 27%, and 1 was found to achieve a relative VSC greater than 80% when compared to the existing value.

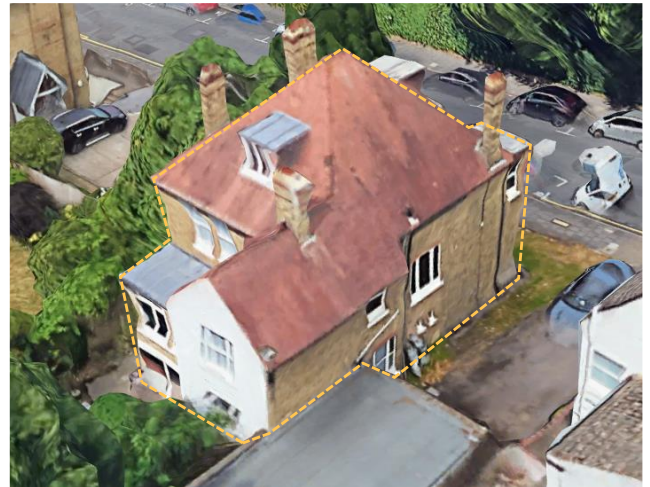
Figure 30: 13 Ethelbert Road windows.

This building is located to the west of the proposed development. Figure 30 shows the assessed windows. The rooms were tested for NSL.

The analysis found that 5 of the 16 assessed windows passed the 25-degree plane test. Of the remaining 11 windows, 8 were found to achieve a VSC greater than 27% and pass the NSL test, and 3 more were found to achieve a relative VSC greater than 80% when compared to the existing value and pass the NSL.

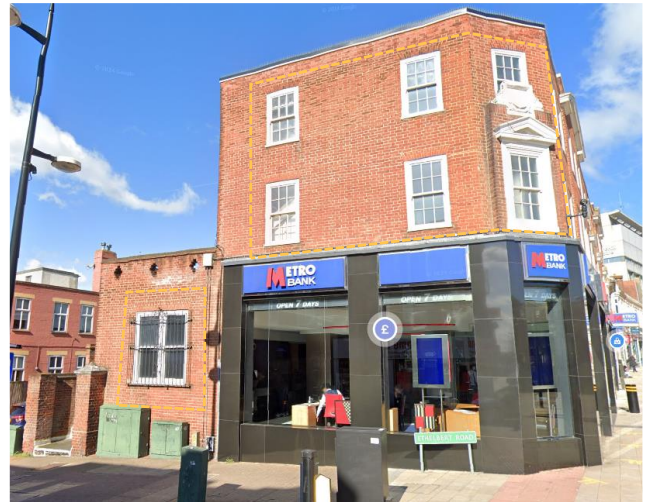
Figure 32: 72-76 High Street windows.

This building is located to the west of the proposed development. Figure 32 shows the assessed windows. Since there was no publicly available information on the building’s internal layout, the rooms were not tested for NSL.

The analysis found that none of the 7 assessed windows passed the 25-degree plane test. Of the remaining 7 windows, 2 were found to achieve a VSC greater than 27%, and 5 were found to achieve a relative VSC greater than 80% when compared to the existing value.

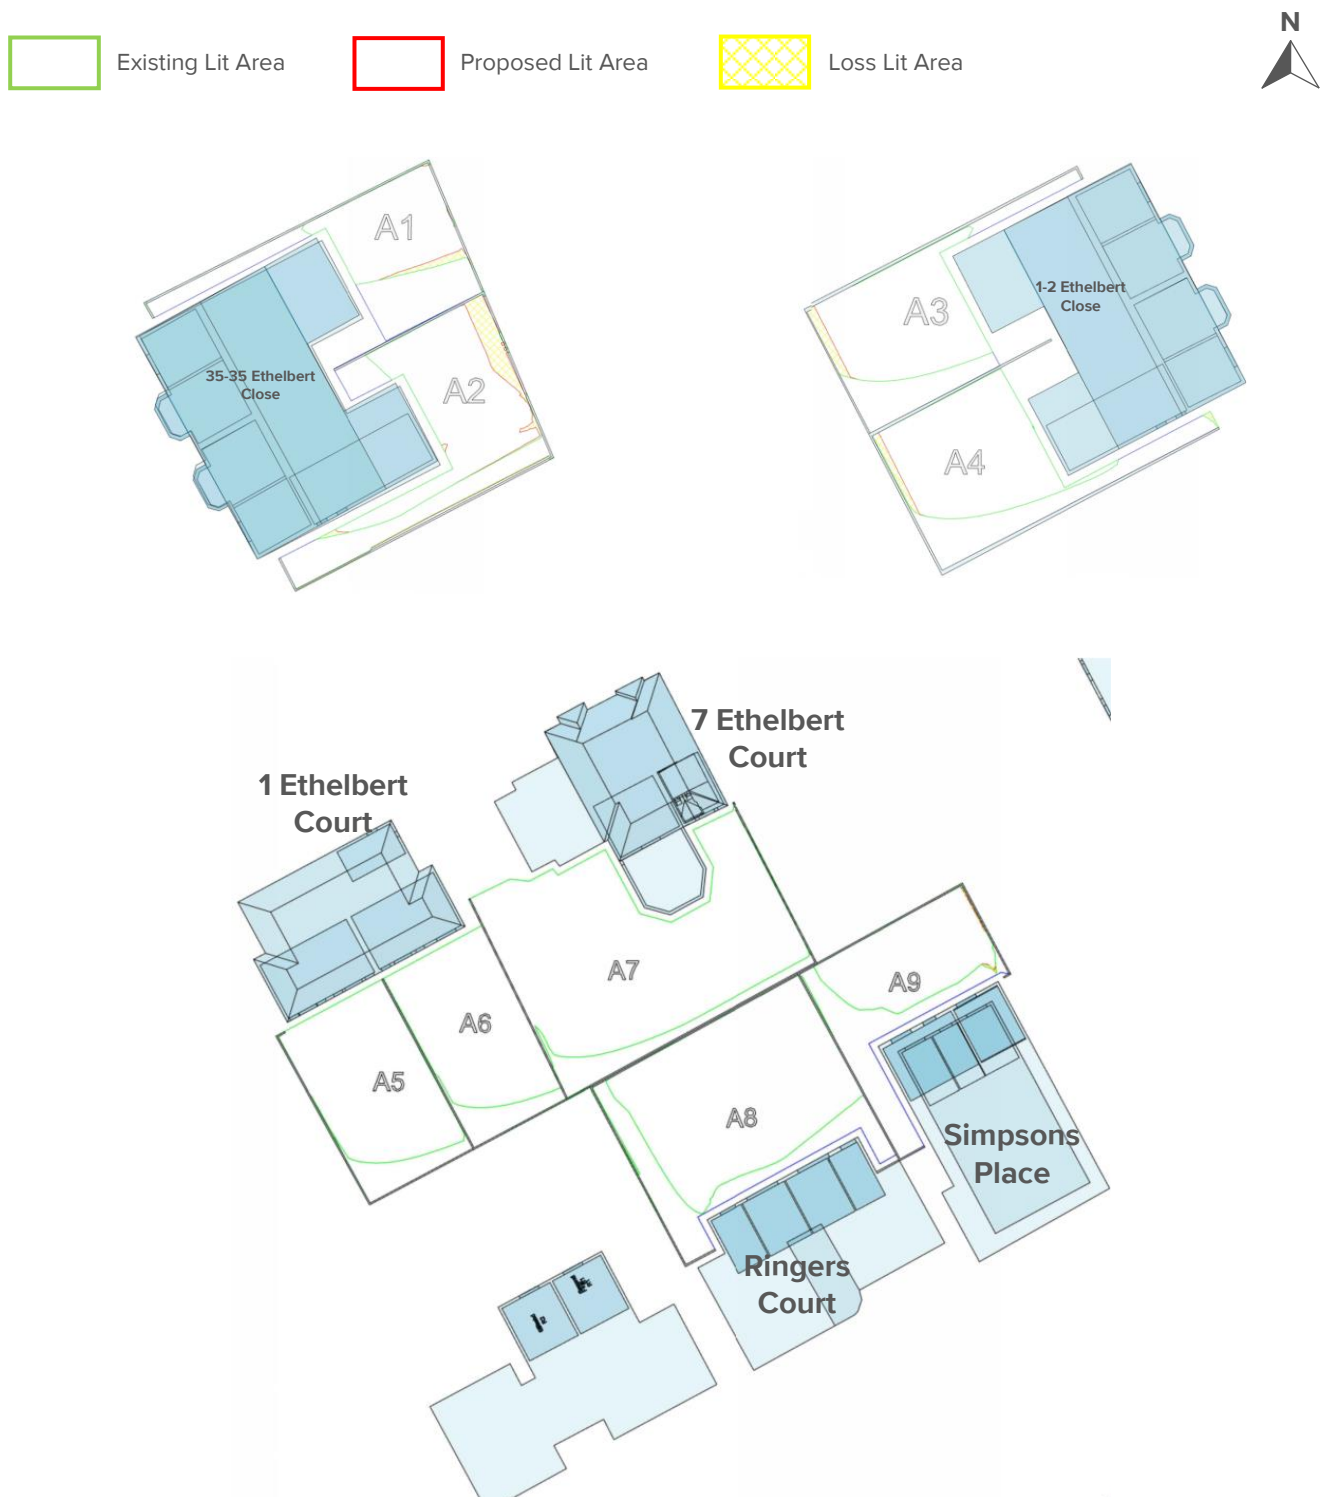
Figure 35: Overshadowing results for existing and proposed cases in amenity spaces.

The images show that at least 50% of each of the analysed spaces will receive more than 2 hours of
